TÜV SÜD Auto Partner GmbH
Wiesenring 2
04159 Leipzig

Expertise

Protocol number: 48368195
Order No. / Reference: 27132412
Inspection date: 27 Oct 2026

Manufacturer: Audi	Model: Q4 e-tron 40 Sportback
VIN: WAUZZZFZ4PP073605

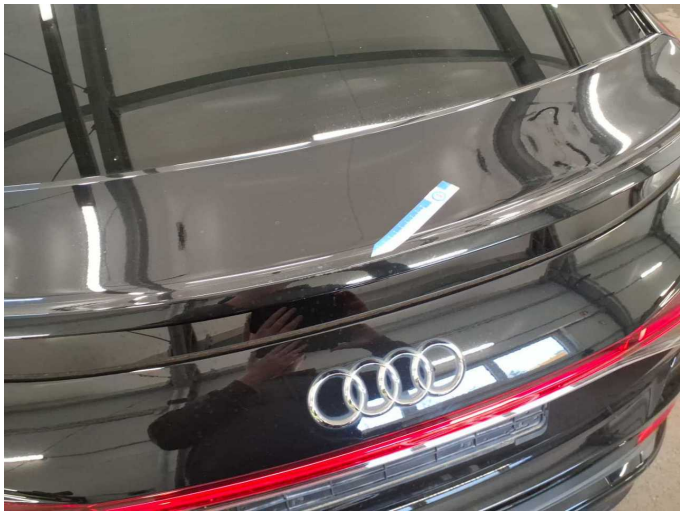
No.	Component group	Description
1	Rear bumper	Rear bumper - Scratch(es) - Smart repair
2	Boot lid / rear door	Rear spoiler - Scratch(es) - Smart repair
3	Wheel / tyres	Alloy rim - rear right side - Scratch(es) - Loss in value
4	Wheel / tyres	Alloy rim - front right side - Scratch(es) - Loss in value

Damage 2: Boot lid / rear door: Rear spoiler - Scratch(es) - Smart repair

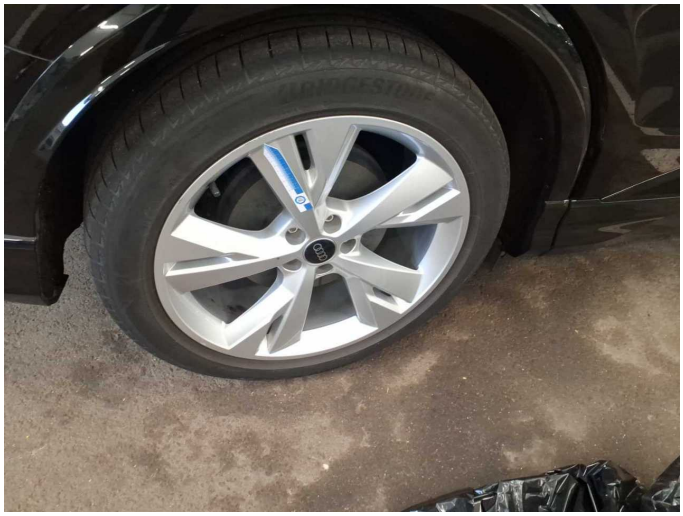
Damage 3: Wheel / tyres: Alloy rim - rear right side - Scratch(es) - Loss in value
