TÜV SÜD Auto Partner GmbH
Wiesenring 2
04159 Leipzig

Expertise

Protocol number: 48421286
Order No. / Reference: 27206527
Inspection date: 27 Oct 2026

Manufacturer: Ford	Model: Transit 310 L2H2 Lkw VA Trend
VIN: WF0XXXTTGXKK53799

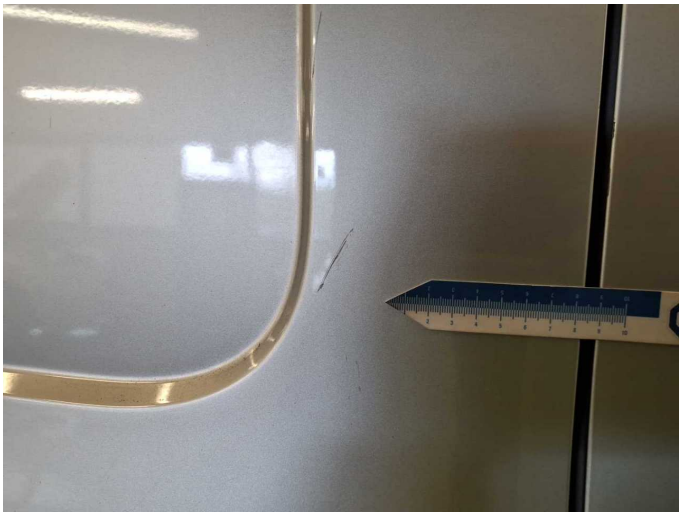
Damage 1: Bonnet: Bonnet (wird erneuert) - Corrosion - Repair and paint

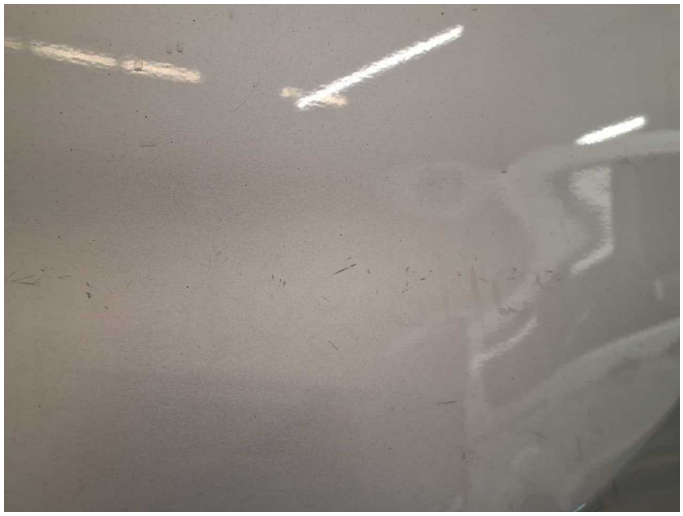
Damage 6: Boot lid / rear door: Rear door - right side - Scratch(es) - Paint

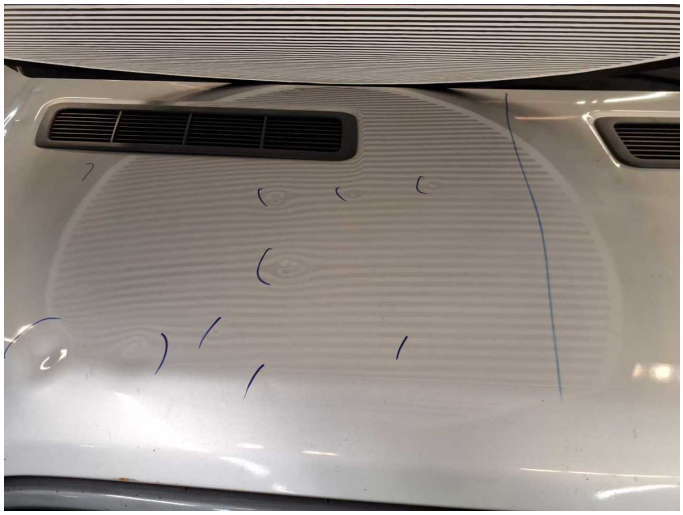
Damage 9: Body: Body - Damage by hail - Repair

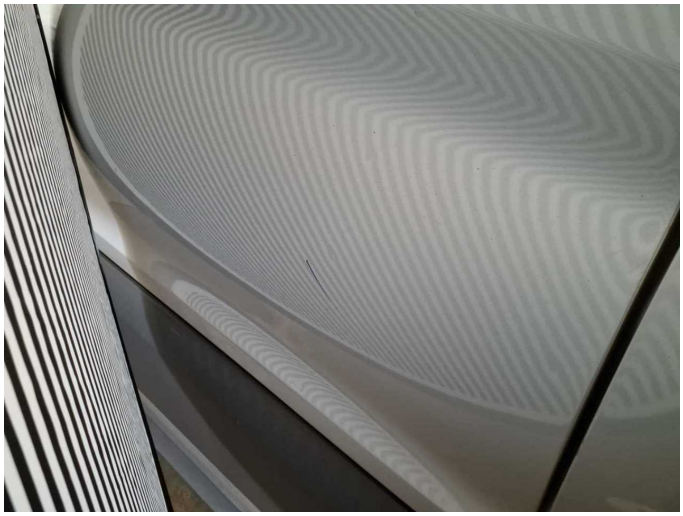
Damage 9: Body: Body - Damage by hail - Repair

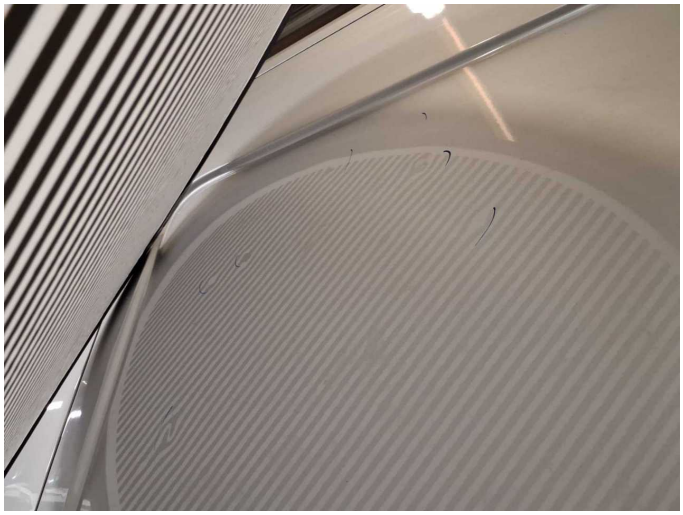
Damage 9: Body: Body - Damage by hail - Repair
