Expertise

Protocol number: 48510994
Order No. / Reference: 26989984-1
Inspection date: 21 Oct 2026

Manufacturer: Ford	Model: Transit 350 L2H2 Lkw VA Trend Kasten
VIN: WF0EXXTTREPE30304

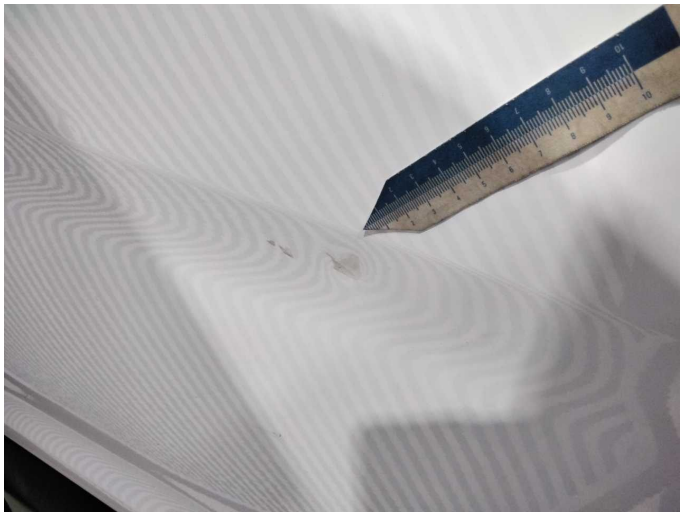
Damage 1: Door - front right side: Door - Dent / paintcoat damage - Smart repair
