Expertise

Protocol number: 47674858
Order No. / Reference: 27012036
Inspection date: 18 Sept 2026

Manufacturer: Skoda	Model: Superb Combi 2.0 TDI DSG Style
VIN: TMBJH7NP7P7042386

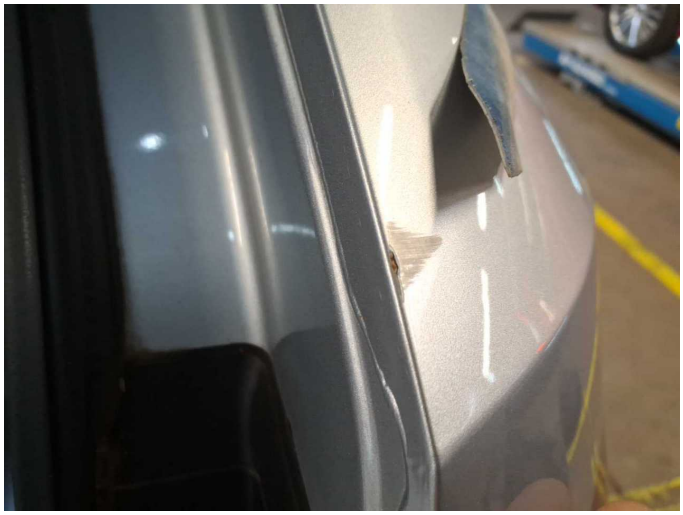
No.	Component group	Description
1	Wheel / tyres	Pressure sensor - Functional / admissibility - Perform diagnosis
2	Equipment	Vehicle key with remote control (2x Batterie) - Empty - Replace
3	Door - front left side	Brightware - lower - Scratch(es) - Smart repair
4	Side panel - rear right side	Side panel (Rostbildung) - Paint defect - Smart repair
5	Wheel / tyres	Tyre - front right side - Damaged - Replace
6	Wheel / tyres	Tyre - front left side (Flanke) - Damaged - Replace
7	Side panel - rear left side	Side panel - Dent / paintcoat damage - Repair and paint
8	Rear bumper	Rear bumper - Scratched - Repair and paint
9	Front bumper	Front bumper - Scratched - Repair and paint

Damage 4: Side panel - rear right side: Side panel (Rostbildung) - Paint defect - Smart repair

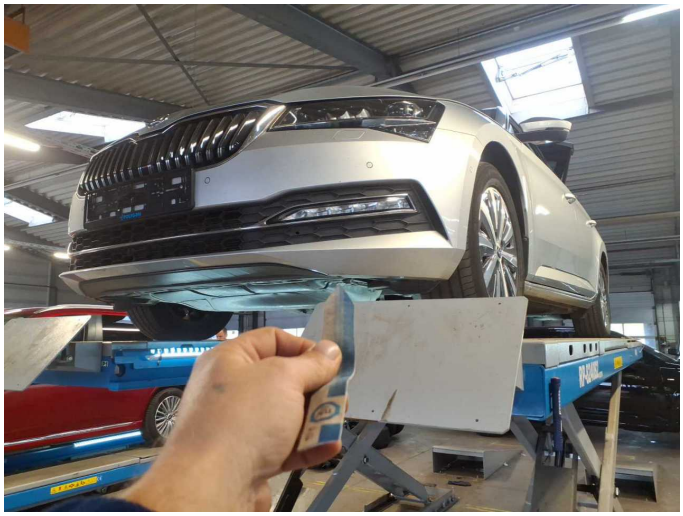
Damage 9: Front bumper: Front bumper - Scratched - Repair and paint
