Expertise

Protocol number: 48449409
Order No. / Reference: 27216691
Inspection date: 2 Nov 2026

Manufacturer: Volkswagen	Model: T-Roc 2.0 TDI SCR DSG R-Line
VIN: WVGZZZA1ZNV134344

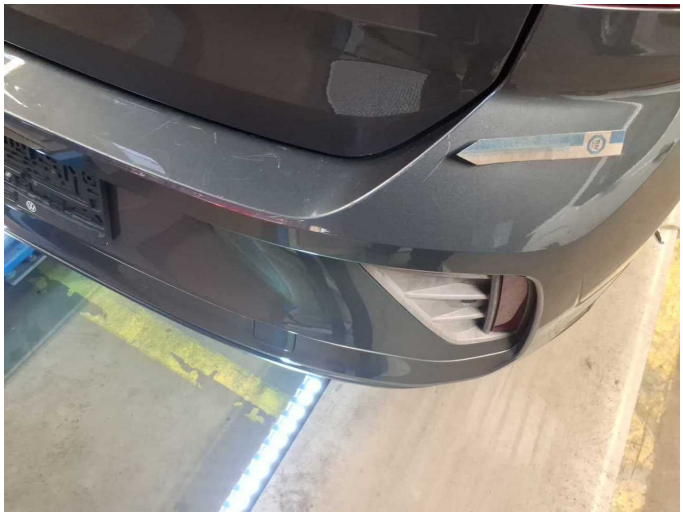
Damage 9: Rear bumper: Rear bumper - Dent / paintcoat damage - Repair and paint

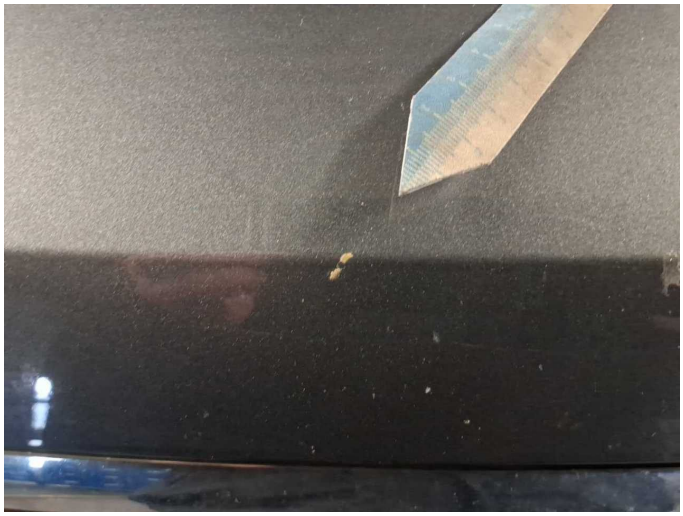
Damage 11: Bonnet: Bonnet (Mehrere) - Stone chips - Paint

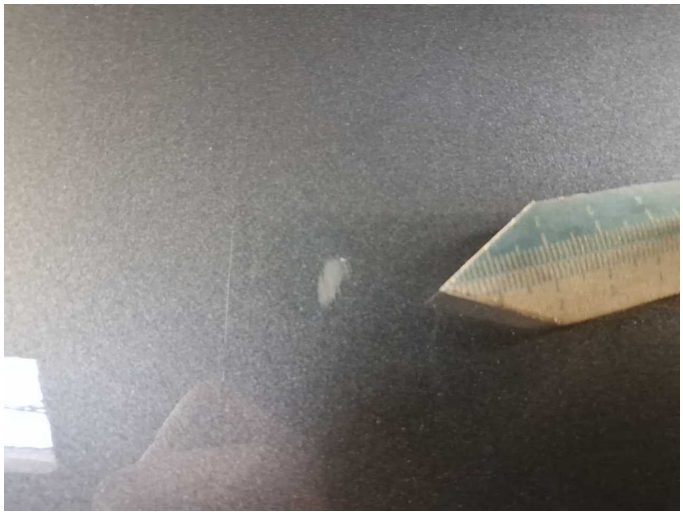
Damage 12: Boot lid / rear door: Boot lid - Dent / paintcoat damage - Repair and paint
