Expertise

Protocol number: 48454522
Order No. / Reference: 27216100
Inspection date: 2 Nov 2026

Manufacturer: Volkswagen	Model: Passat Variant 2.0 TDI SCR DSG Business
VIN: WVWZZZ3CZPE029777

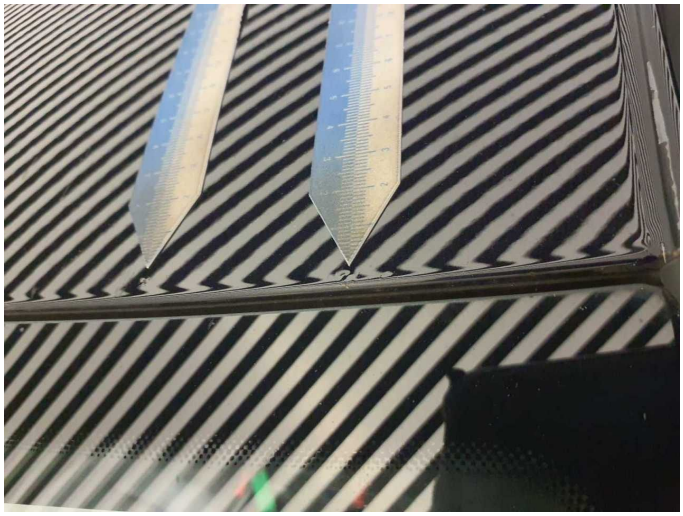
Damage 3: Roof: Roof (Dachkante) - Corrosion - Smart repair

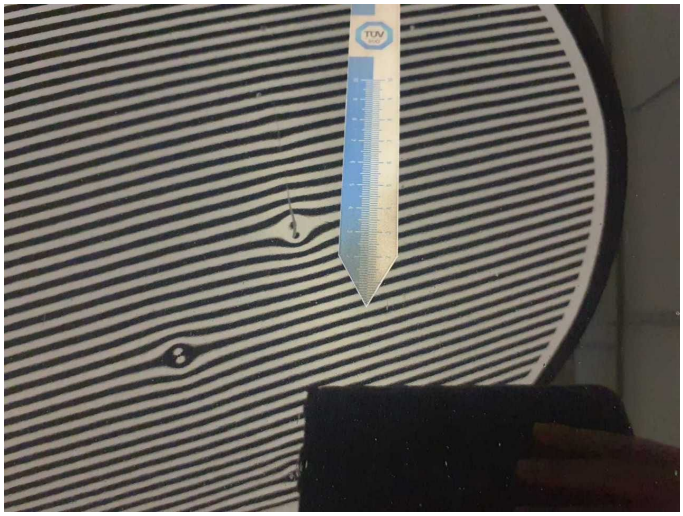
Damage 8: Bonnet: Bonnet - Corrosion - Repair and paint
