Expertise

Protocol number: 48492536
Order No. / Reference: 27134940
Inspection date: 4 Nov 2026

Manufacturer: Skoda	Model: Octavia Combi 2.0 TDI DSG RS
VIN: TMBJK0NX7NY076022

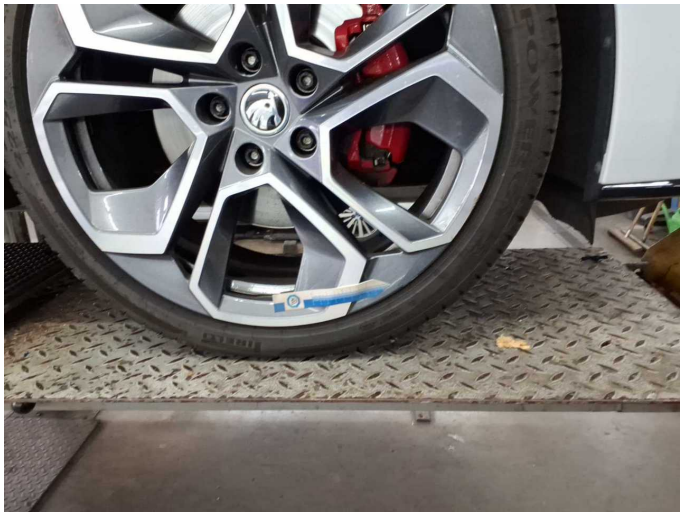
Damage 7: Wheel / tyres: Alloy rim - front right side - Scratched - Replace

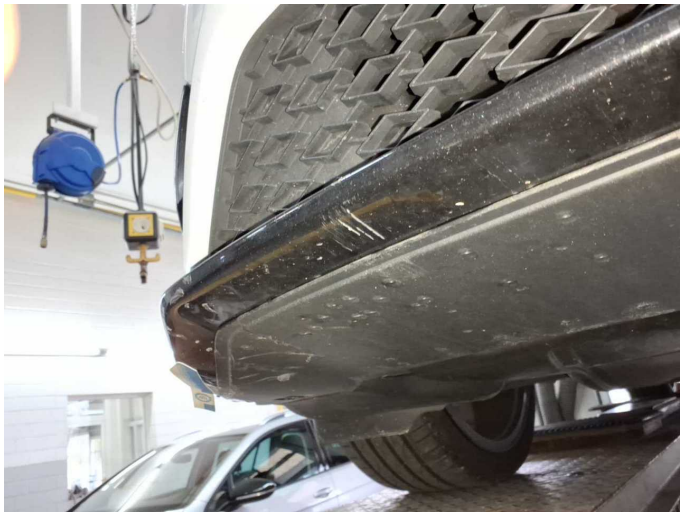
Damage 8: Front bumper: Spoiler - Scratched - Paint
