Inspection date: 5 Oct 2026
Protocol number: **47919350**

WBY31AW070FN49438

Zustandsbericht

Manufacturer	BMW	**Inspection condition**	sufficient
Type / Model	i4 xDrive M50	**Mileage (Read)**	11,101 km
Vehicle Identification number	WBY31AW070FN49438	**First registration**	24 Aug 2022

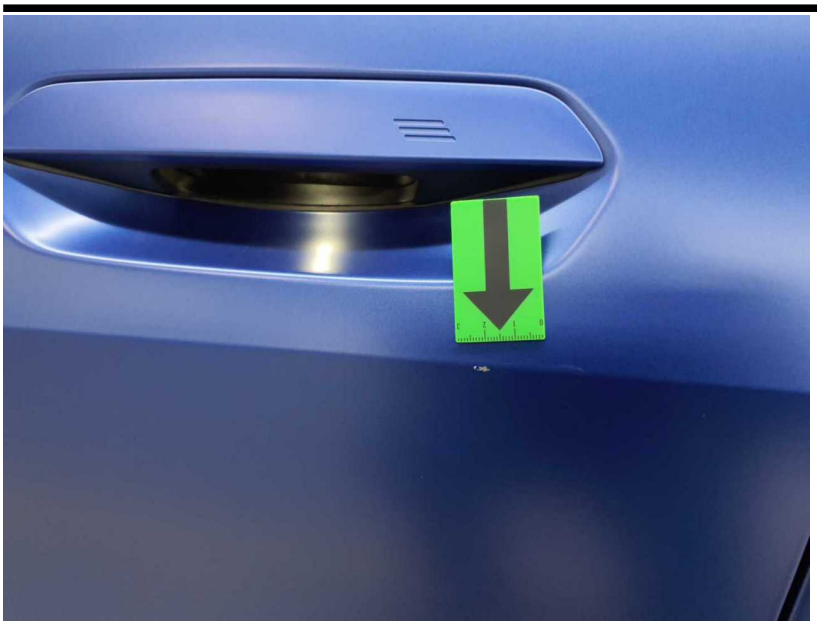
No.	Component group	Description
1	Door - front left side	Door - Scratch(es) - Smart repair
2	Wheel / tyres	Alloy rim - rear right side - Scratched - Repair
3	Wheel / tyres	Alloy rim - front right side - Scratched - Repair

Damage Door - front left side: Door - front left side: Door - Scratch(es) - Smart repair

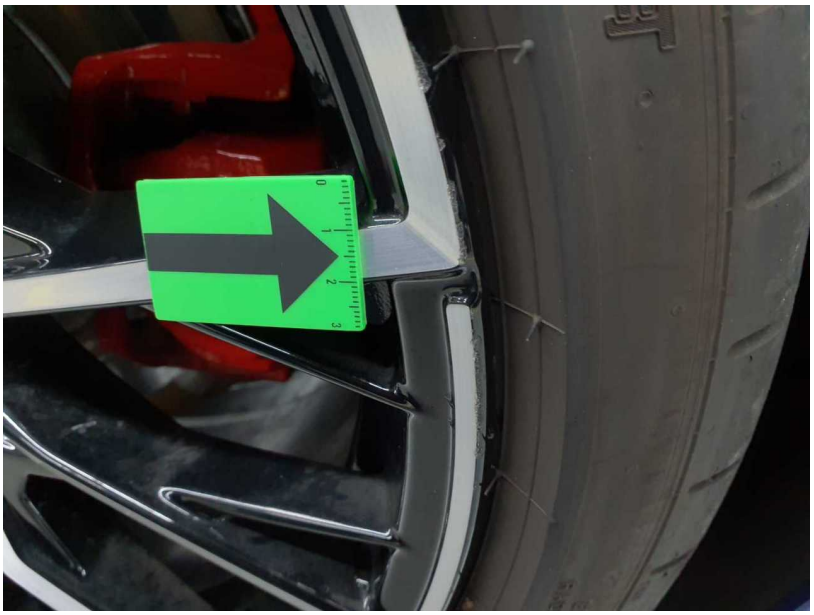
Damage Wheel / tyres: Wheel / tyres: Alloy rim - rear right side - Scratched - Repair
