ARVAL
BNP PARIBAS GROUP

1XTF326

INSPECTION REPORT

End of contract

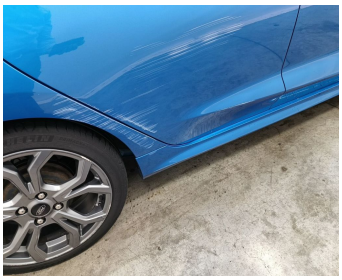
Door Front Left // Smart Repair Small-scratch

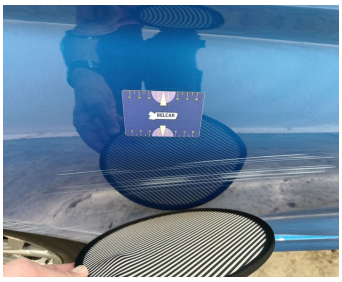
Bumper Front // Painting-scratch

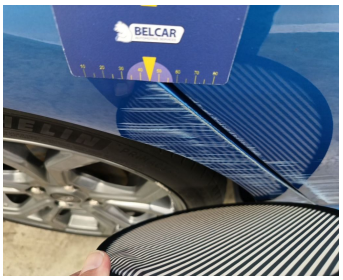
Bumper Rear // Painting-scratch
