TÜV SÜD Auto Partner GmbH
Wiesenring 2
04159 Leipzig

Expertise

Protocol number: 48067357
Order No. / Reference: 27095016
Inspection date: 12 Oct 2026

Manufacturer: Mercedes-Benz	Model: GLA 200 d 4Matic 8G-DCT AMG Line
VIN: W1N4N1DB1PJ533430

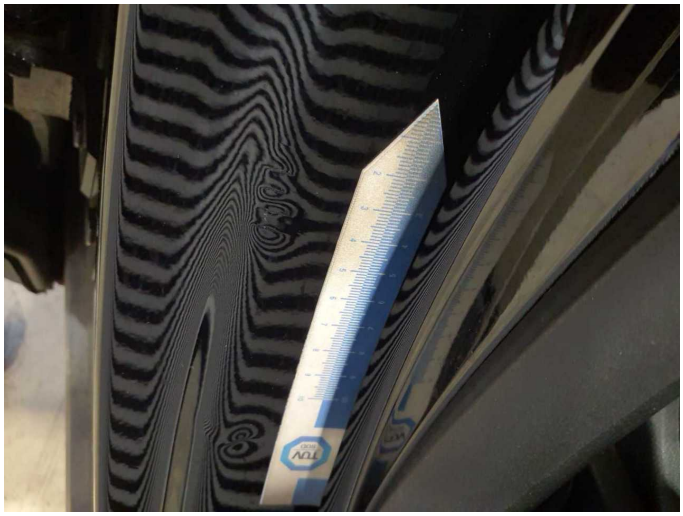
Damage 1: Body: B-pillar - right side - dent(s) - Smart repair

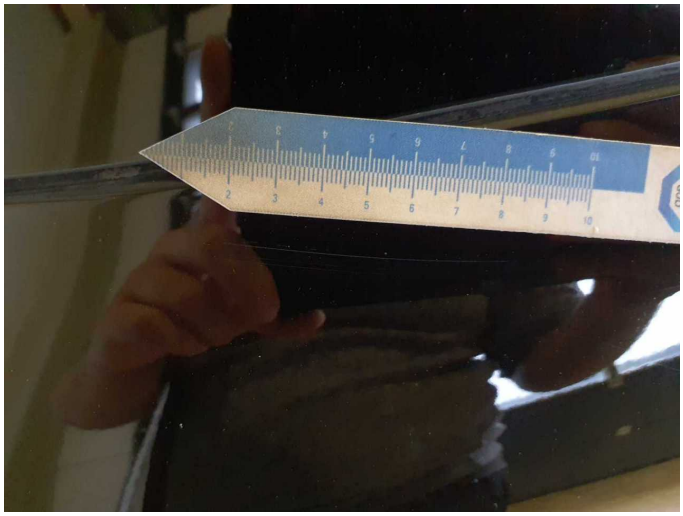
Damage 2: Boot lid / rear door: Boot lid - Dent / paintcoat damage - Smart repair

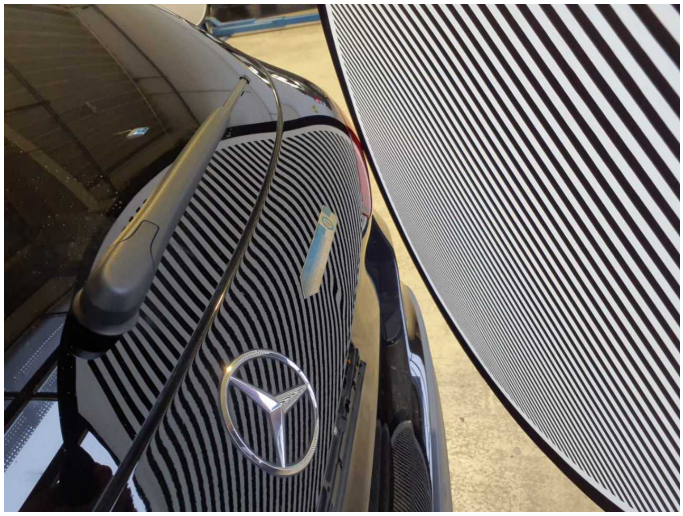
Damage 2: Boot lid / rear door: Boot lid - Dent / paintcoat damage - Smart repair

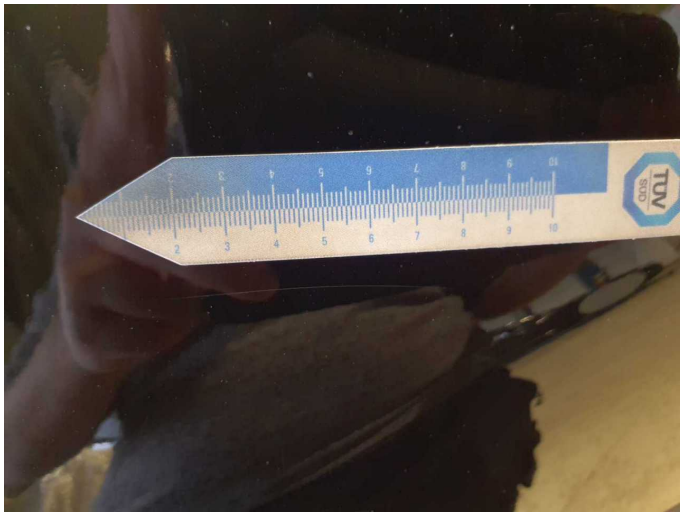
Damage 3: Side panel - rear right side: Side panel - Scratch(es) - Smart repair

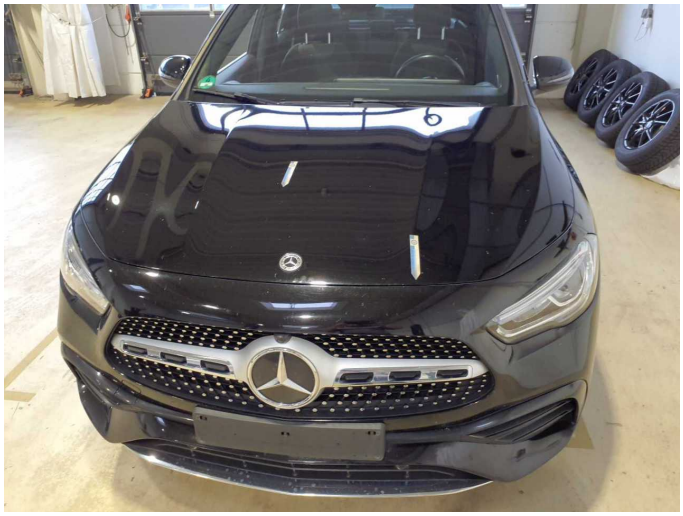
Damage 4: Bonnet: Bonnet - Stone chips - Paint

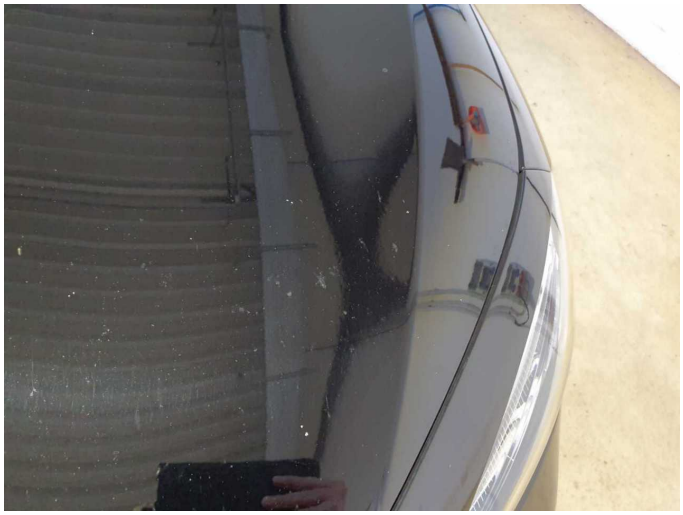
Damage 4: Bonnet: Bonnet - Stone chips - Paint

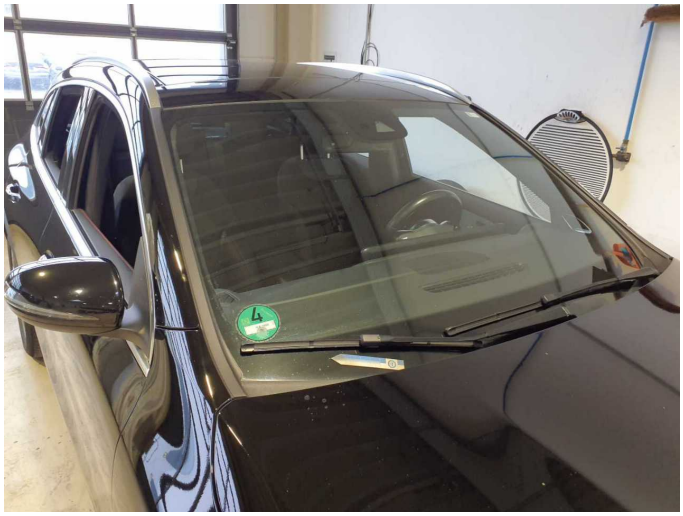
Damage 5: Vehicle glazing: Windscreen (Randbereich) - Broken / torn - repair according to calculation
