Expertise

Protocol number: 48417677
Order No. / Reference: 27192389
Inspection date: 29 Oct 2026

Manufacturer: Skoda	Model: Octavia Combi 2.0 TDI DSG Style
VIN: TMBJJ8NX5PY029494

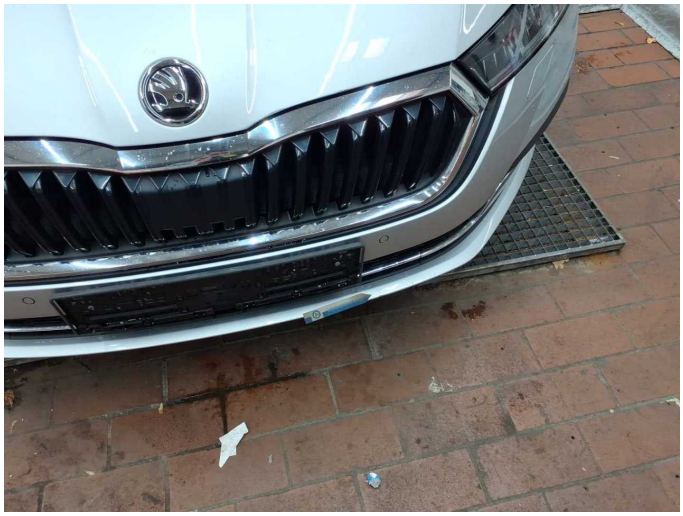
No.	Component group	Description
1	Equipment	Tirefit filler - Expired - Replace
2	Wheel / tyres	Alloy rim - front right side - Scratched - Loss in value
3	Bonnet	Bonnet - Scratch(es) - Paint
4	Front bumper	Front bumper - Scratched - Repair and paint

Damage 3: Bonnet: Bonnet - Scratch(es) - Paint
