TÜV SÜD Auto Partner GmbH
Wiesenring 2
04159 Leipzig

Expertise

Protocol number: 48603431
Order No. / Reference: 27223376
Inspection date: 10 Nov 2026

Manufacturer: Volkswagen	Model: Multivan T7 Kurz
VIN: WV2ZZZST7RH029021

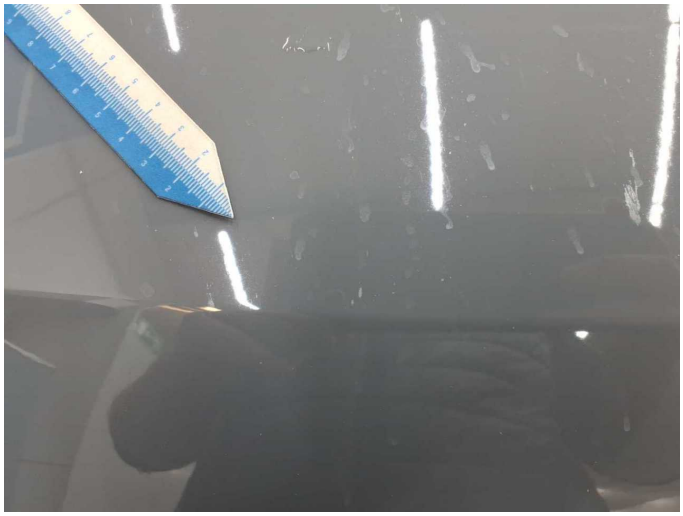
Damage 1: Bonnet: Bonnet - Dent / paintcoat damage - Smart repair
