Expertise

Protocol number: 48508665
Order No. / Reference: 27135195
Inspection date: 3 Nov 2026

Manufacturer: Mercedes-Benz	Model: GLC 300 e 4Matic 9G-TRONIC AMG Line Advanced
VIN: W1NKM5GBXPF028261

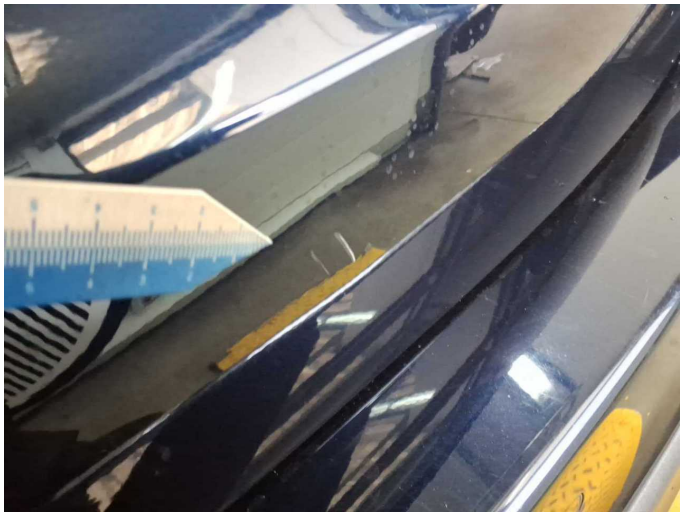
Damage 5: Boot lid / rear door: Boot lid (unterhalb) - Dent / paintcoat damage - Paint

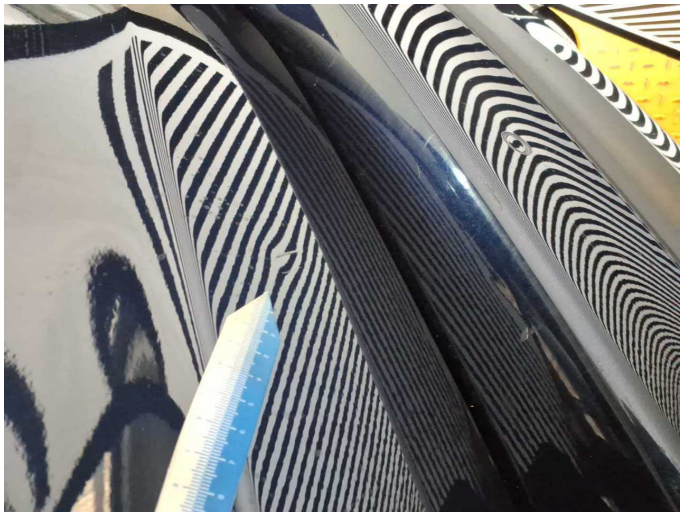
Damage 5: Boot lid / rear door: Boot lid (unterhalb) - Dent / paintcoat damage - Paint

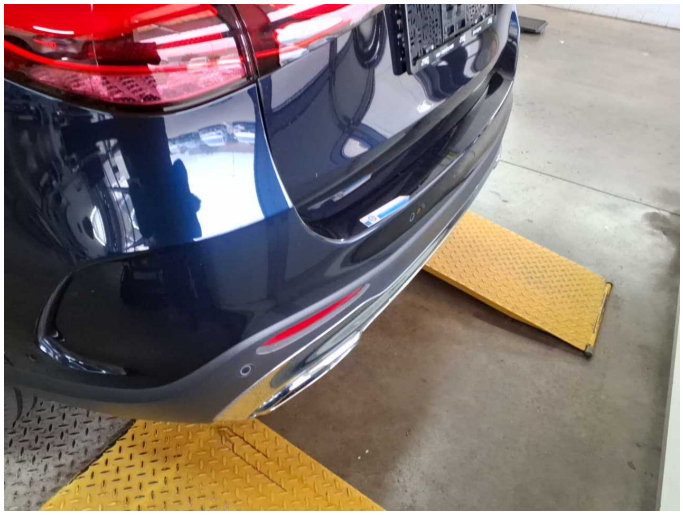
Damage 5: Boot lid / rear door: Boot lid (unterhalb) - Dent / paintcoat damage - Paint

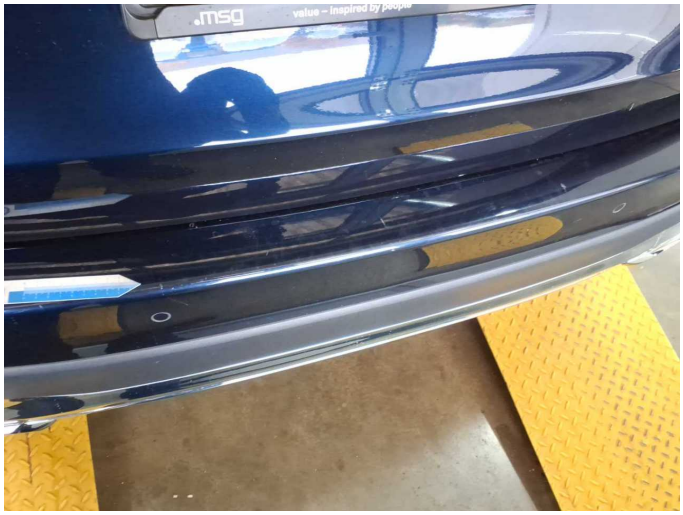
Damage 6: Rear bumper: Rear bumper - Scratch(es) - Paint

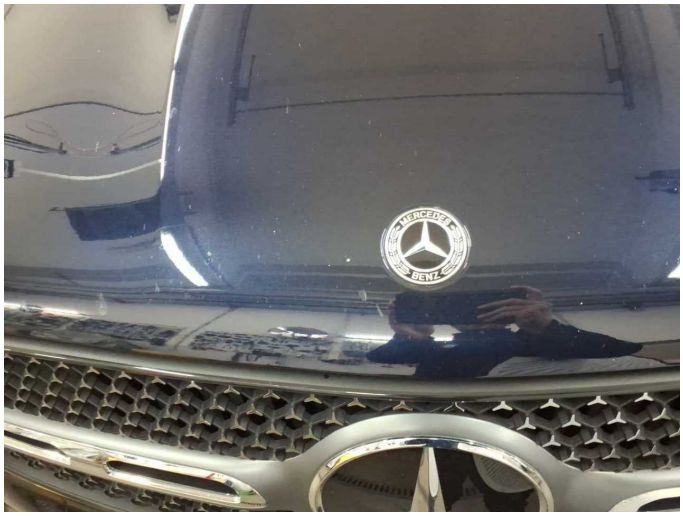
Damage 7: Bonnet: Bonnet - Stone chips - Paint

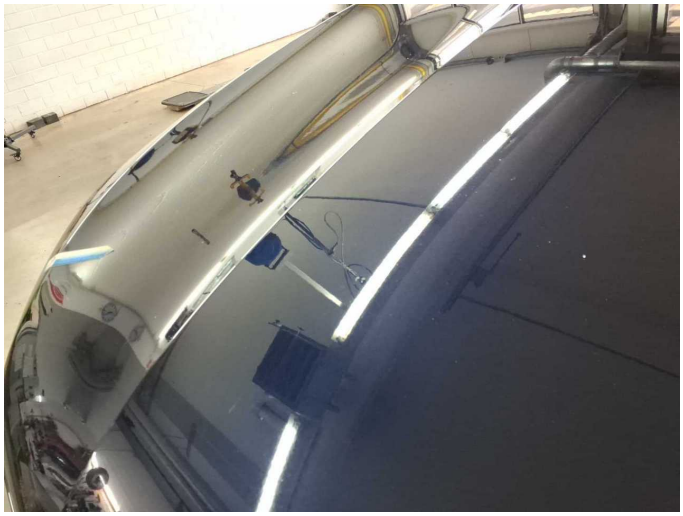
Damage 7: Bonnet: Bonnet - Stone chips - Paint
