Expertise

Protocol number: 48573969
Order No. / Reference: 27199704
Inspection date: 9 Nov 2026

Manufacturer: Volkswagen	Model: Tiguan 2.0 TDI SCR DSG Life
VIN: WVGZZZ5N3RW018861

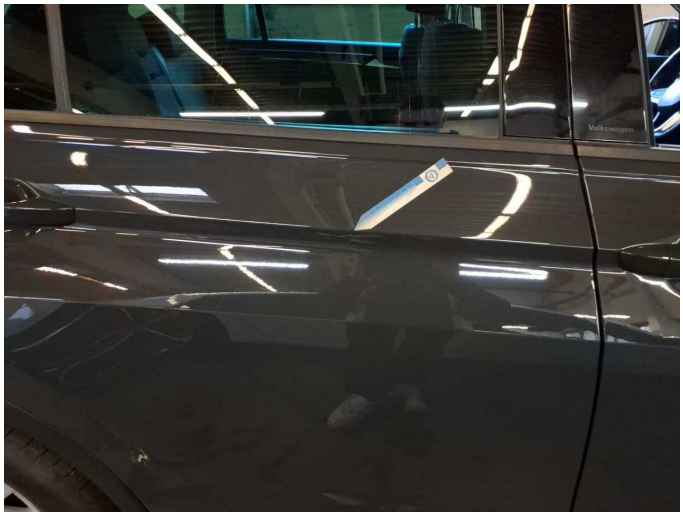
Damage 3: Door - rear left side: Door - Scratch(es) - Paint

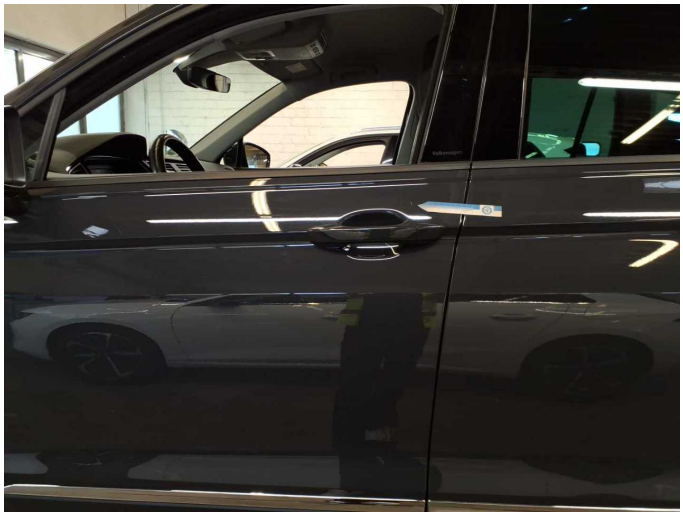
Damage 4: Door - rear right side: Door - Scratch(es) - Paint

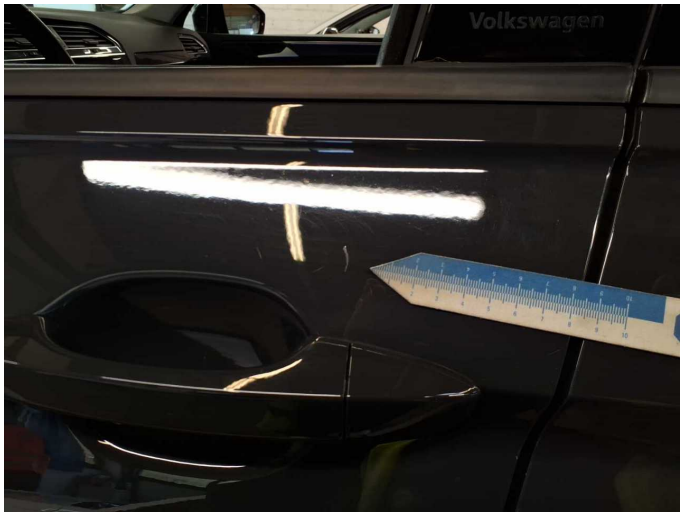
Damage 5: Door - front left side: Door - Scratch(es) - Paint

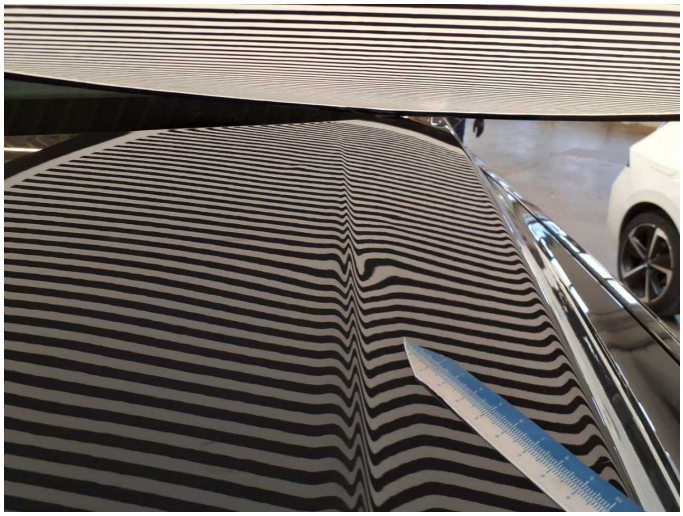
Damage 7: Bonnet: Bonnet - Deformed - Repair and paint
