Macadam Austria GmbH
Europaplatz 2/1/2
1150 Wien

Inspection date: 11 Sept 2026
Protocol number: **47534878**

WBAYN910305X73147

Zustandsbericht

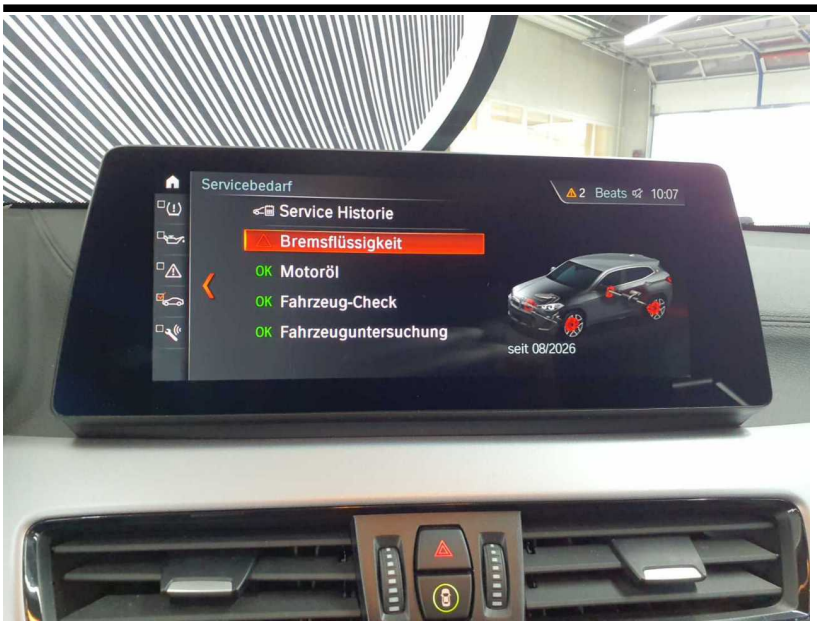
No.	Component group	Description
1	Seat - front	Seat base trim - left side - Scratched - Smart repair
2	Door - rear right side	Door (2 M) - dent(s) - Smooth repair work
3	Braking system	Brake fluid - Due - Replace
4	Rear bumper	Bumper with Parktronic (Ladekante) - Scratched - Smart repair

Damage Door - rear right side: Door - rear right side: Door (2 M) - dent(s) - Smooth repair work
