# MACADAM
# Volkswagen ID.4 '21 BEV

| Model: | **ID.4 '21 BEV** | VIN: | **WVGZZZE2ZNP008775** |
| Version: | **ID.4 77kWh Business** | First registration | **15/10/2021** |

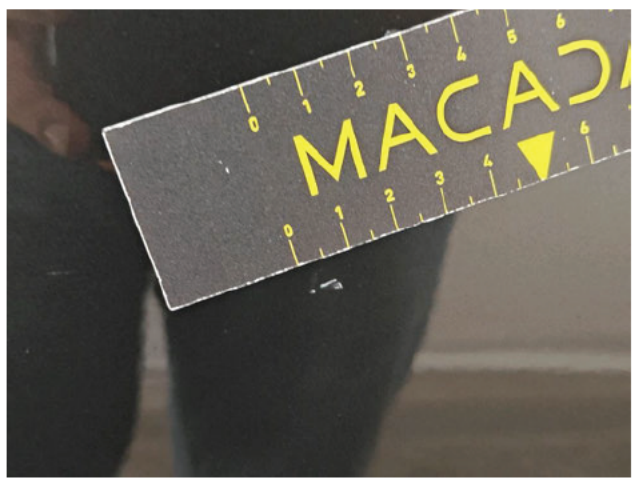
**Bonnet**
Chemical polution
Repair and paint (complete)
Front

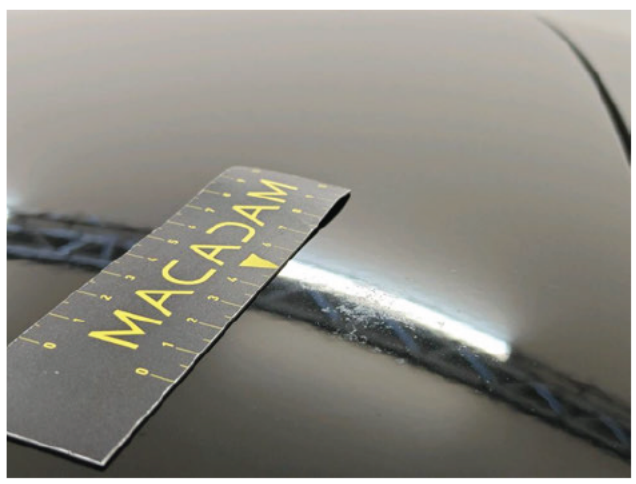
**Door FR**
Scratch(es)
Repair and paint (complete)
Right

**Door RR**
Scratch(es)
Repair and paint (complete)
Right

**Roof**
Chemical polution
Repair and paint (complete)
Roof & others
