Macadam Austria GmbH
Europaplatz 2/1/2
1150 Wien

Inspection date: 18 Sept 2026
Protocol number: **47666591**

WBA51GN0905060511

Zustandsbericht

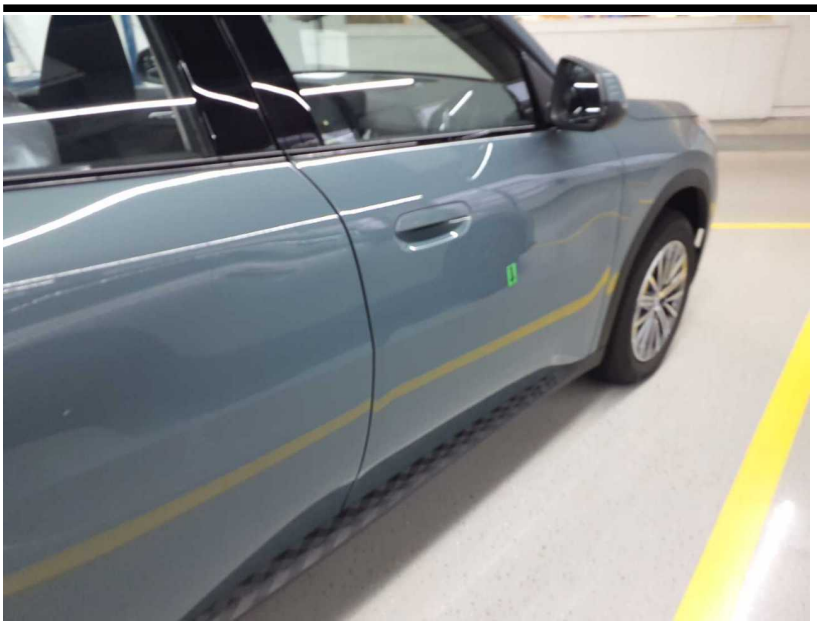
Damage Door - rear right side: Door - rear right side: Door (1 S auf Kante) - dent(s) - Smooth repair work

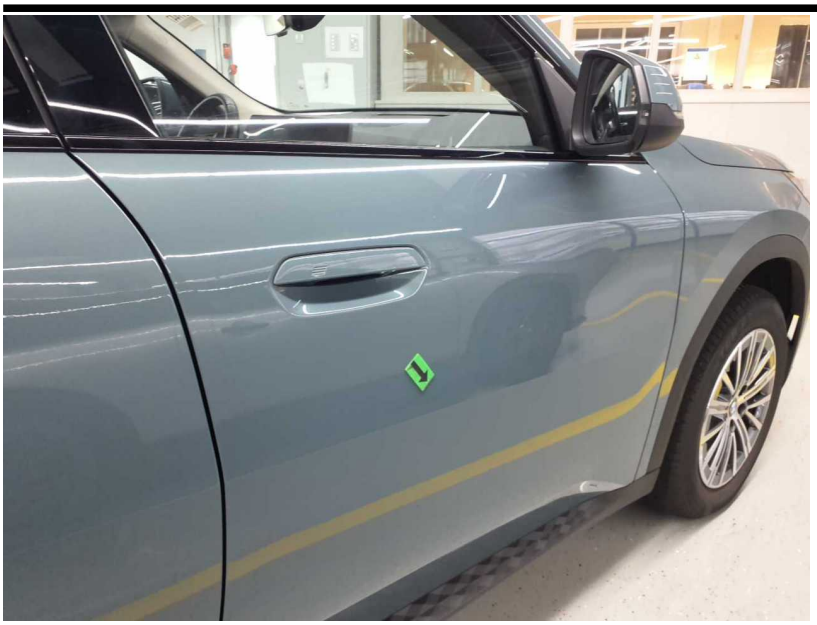
Damage Door - front right side: Door - front right side: Door (2 M eine auf Kante) - dent(s) - Smooth repair work
