Expertise

Protocol number: 47996022
Order No. / Reference: 27130903
Inspection date: 7 Oct 2026

Manufacturer: Mercedes-Benz	Model: A 250 e 8G-DCT Progressive Advanced
VIN: W1K3F8FBXPN316625

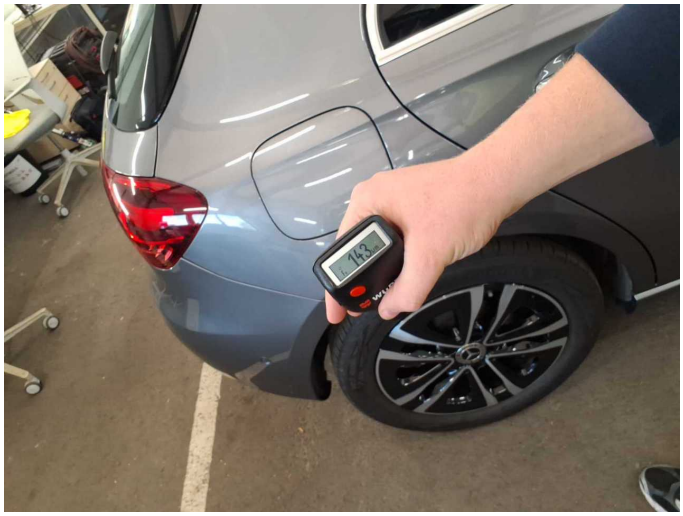
No.	Repainting
1	Side panel - rear right side, Professionally carried out, Invoice of repair done Non-existent

Side panel - rear right side	143 µm

Repainting 1: Side panel - rear right side
