Expertise

Protocol number: 48547933
Order No. / Reference: 27262894
Inspection date: 4 Nov 2026

Manufacturer: Skoda	Model: Superb Combi 2.0 TDI DSG 4x4 L&K
VIN: TMBLR0NZ0SC008997

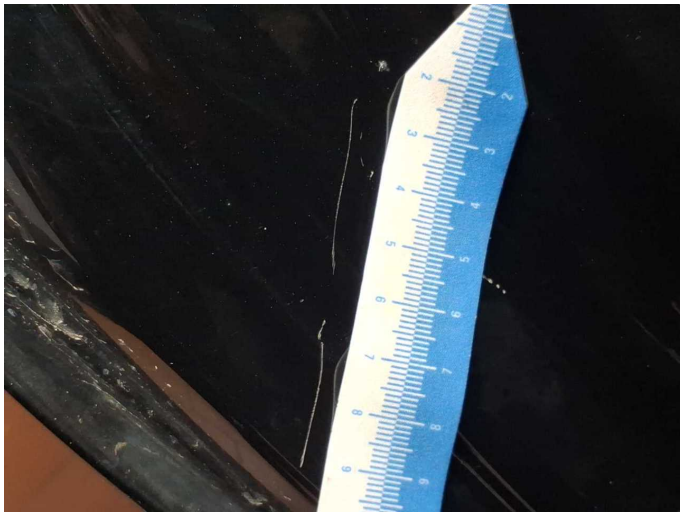
Damage 2: Side panel - rear right side: Sill - Scratch(es) - Smart repair

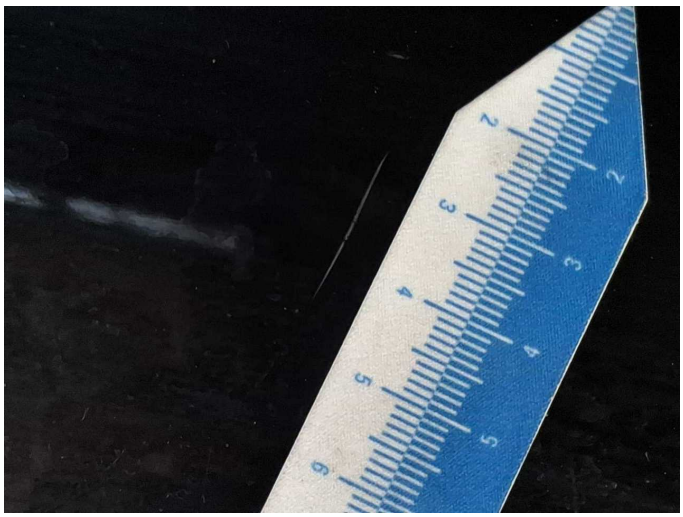
Wear and tear 3: Rear bumper: Rear bumper (Ladekante) - Scratch(es) - No deduction

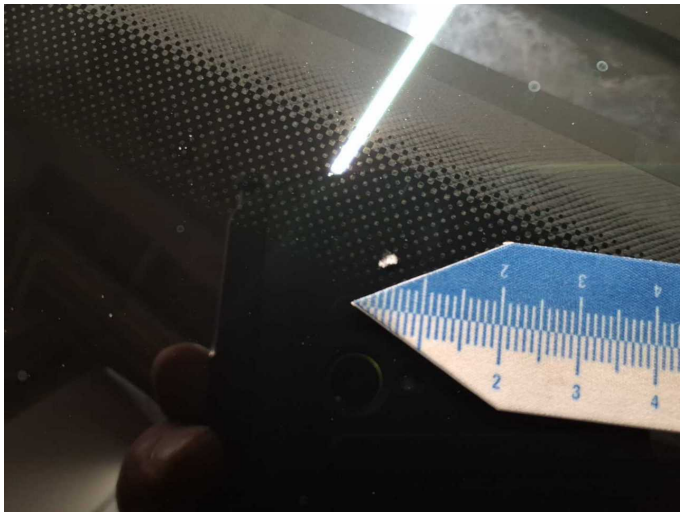
Wear and tear 4: Vehicle glazing: Windscreen - Stone chips - No deduction
