Expertise

Protocol number: 48617505
Order No. / Reference: 27182483
Inspection date: 11 Nov 2026

Manufacturer: Ford	Model: Transit Connect 220 L1 Autm. Trend
VIN: WF0RXXWPGRPC37643

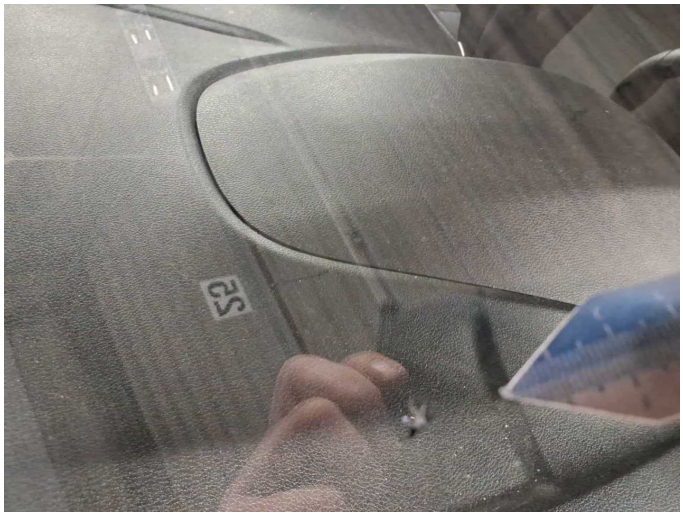
Damage 4: Vehicle glazing: Windscreen with lane departure assistant - Stone chips - Replace
