Expertise

Protocol number: 48520583
Order No. / Reference: 27234466
Inspection date: 3 Nov 2026

Manufacturer: Audi	Model: A3 35 TDI Sportback S tronic advanced
VIN: WAUZZZGY5RA013697

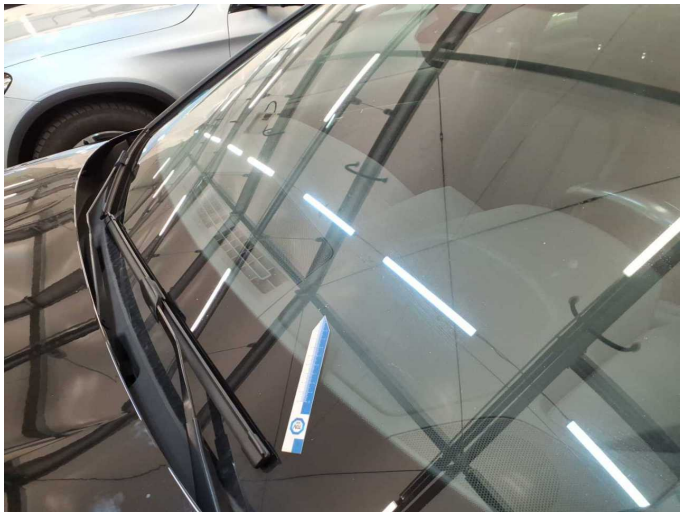
No.	Component group	Description
1	Boot lid / rear door	Boot lid - Glued / labelled - Remove
2	Front bumper	Front bumper - Scratch(es) - Smart repair
3	Vehicle glazing	Windscreen (Rißbildung) - Broken / torn - repair according to calculation

Damage 3: Vehicle glazing: Windscreen (Rißbildung) - Broken / torn - repair according to calculation
