Expertise

Protocol number: 48240270
Order No. / Reference: 27094905
Inspection date: 20 Oct 2026

Manufacturer: Skoda	Model: Kodiaq 2.0 TDI DSG Style
VIN: TMBJJ7NSXP8038058

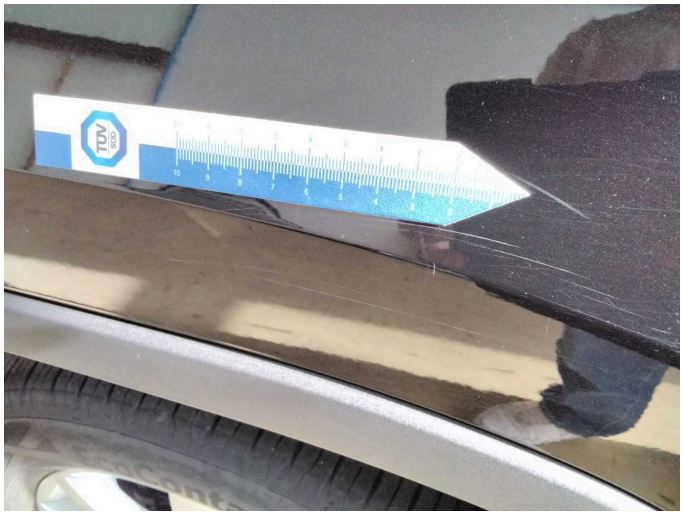
Damage 3: Side panel - rear left side: Side panel - Scratch(es) - Paint

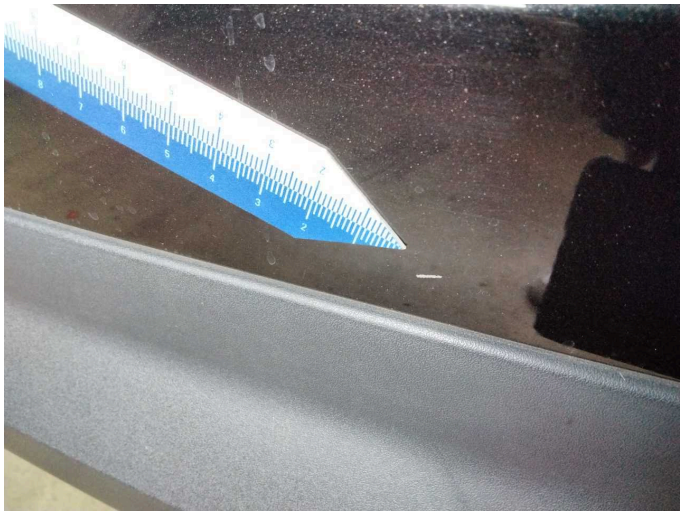
Damage 4: Rear bumper: Rear bumper - Scratch(es) - Paint

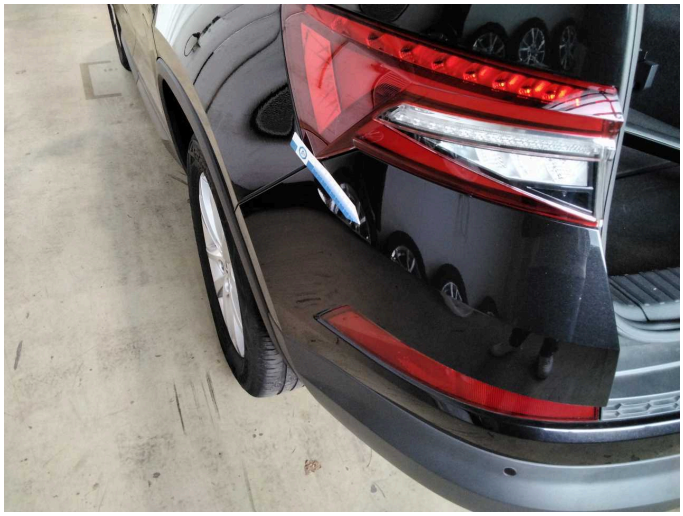
Damage 4: Rear bumper: Rear bumper - Scratch(es) - Paint

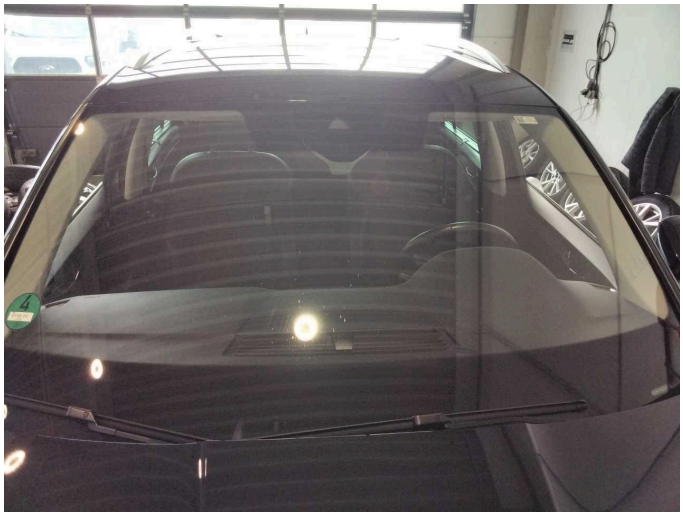
No.	Component group	Description
1	Vehicle glazing	Windscreen - Stone chips - No deduction
2	Front bumper	Front bumper - Stone chips - No deduction

Wear and tear 1: Vehicle glazing: Windscreen - Stone chips - No deduction
