Expertise

Protocol number: 48111998
Order No. / Reference: 27006120
Inspection date: 25 Sept 2026

Manufacturer: Opel	Model: Insignia Sports Tourer 1.5 Diesel Business Edition
VIN: W0VZM8EN3M1026435

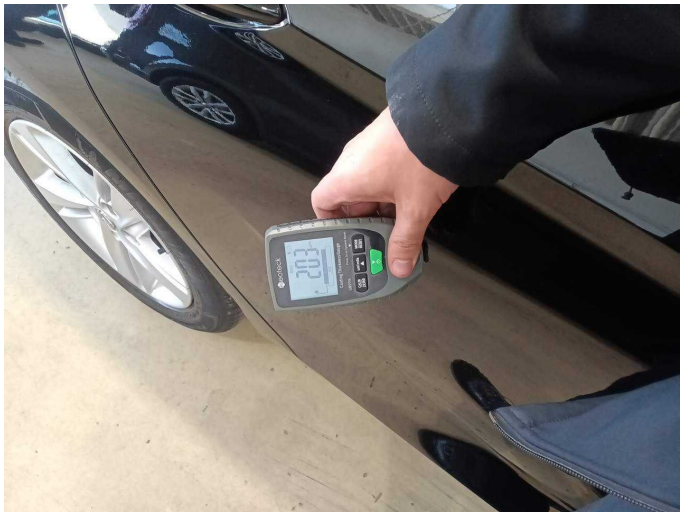
No.	Component group	Description
1	Mudguard - left side	Mudguard - left side - dent(s) - Smooth repair work
2	Trim / covers	Door trim - rear right side - dent(s) - Smart repair
3	Side panel - rear right side	Sill - Scratch(es) - Smart repair
4	Front bumper	Front bumper - Scratch(es) - Smart repair
5	Roof	Roof - Scratch(es) - Paint

Damage 5: Roof: Roof - Scratch(es) - Paint
