TÜV SÜD Auto Partner GmbH
Wiesenring 2
04159 Leipzig

Expertise

Protocol number: 48585508
Order No. / Reference: 27226011
Inspection date: 5 Nov 2026

Manufacturer: Opel	Model: Mokka 1.5 Diesel Business Elegance
VIN: VXKUDYHSKMW054087

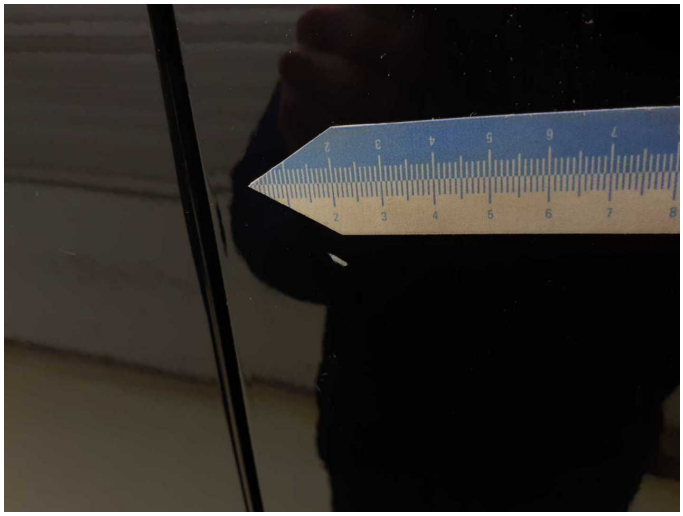
Damage 3: Side panel - rear left side: Side panel - Scratch(es) - Smart repair

Damage 4: Door - front right side: Door - Scratch(es) - Smart repair

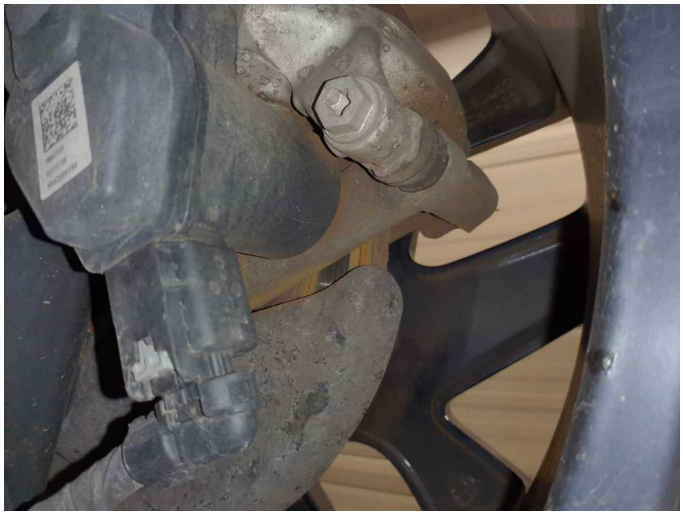
Damage 6: Braking system: Brake discs and pads - rear - Corrosion - Replace

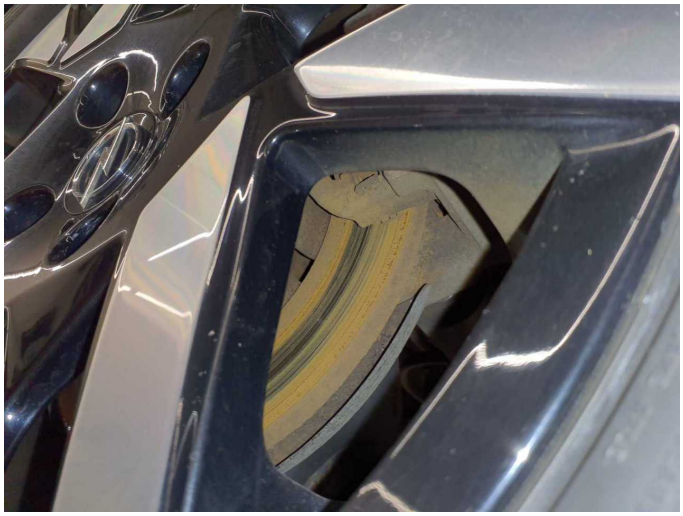
Damage 6: Braking system: Brake discs and pads - rear - Corrosion - Replace

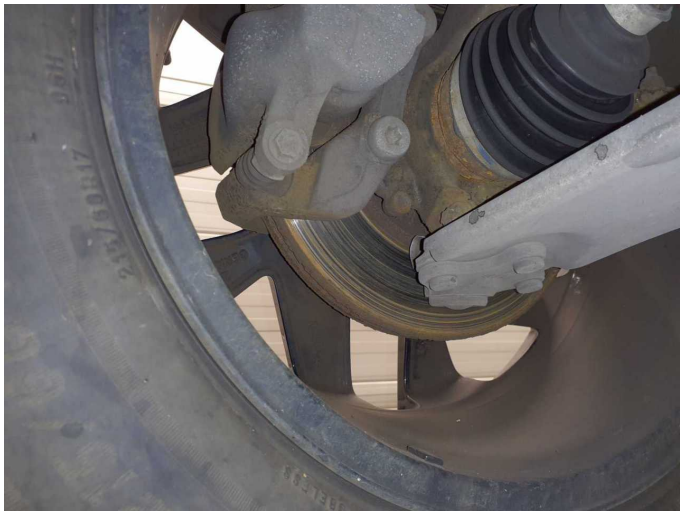
Damage 7: Braking system: Brake discs and brake pads - front (Korrosion und) - Worn - Replace

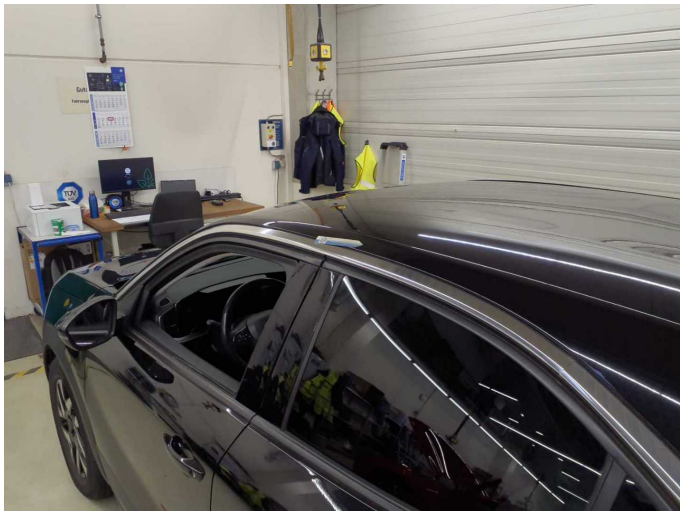
Damage 7: Braking system: Brake discs and brake pads - front (Korrosion und) - Worn - Replace

Damage 8: Body: Body (Hagelschaden) - dent(s) - Repair

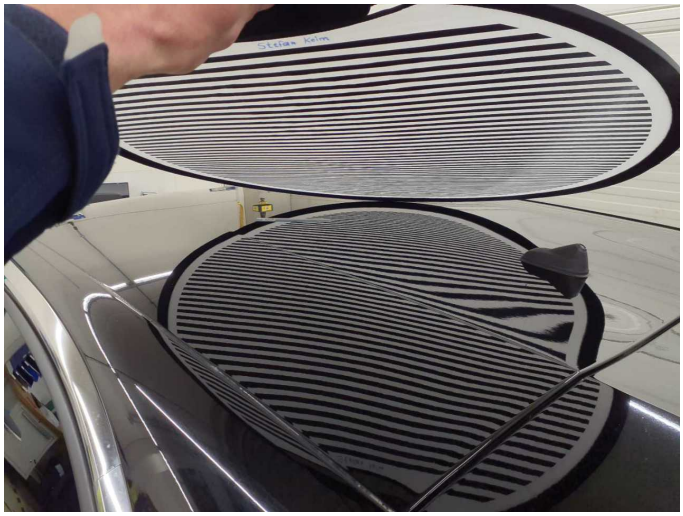
Damage 8: Body: Body (Hagelschaden) - dent(s) - Repair

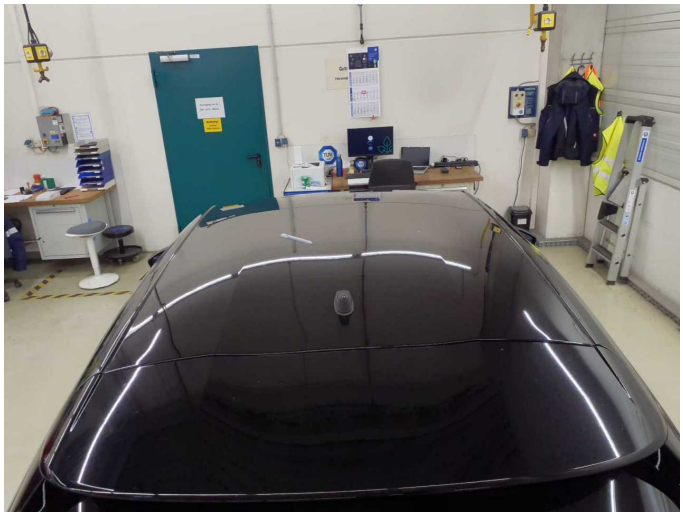
Damage 8: Body: Body (Hagelschaden) - dent(s) - Repair

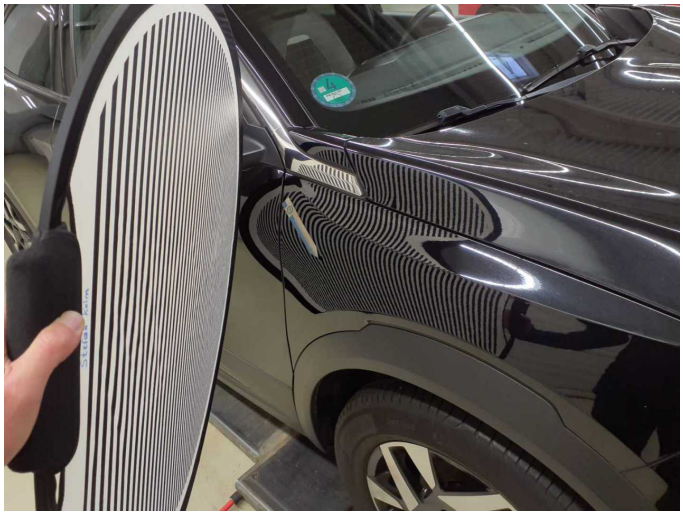
Damage 8: Body: Body (Hagelschaden) - dent(s) - Repair

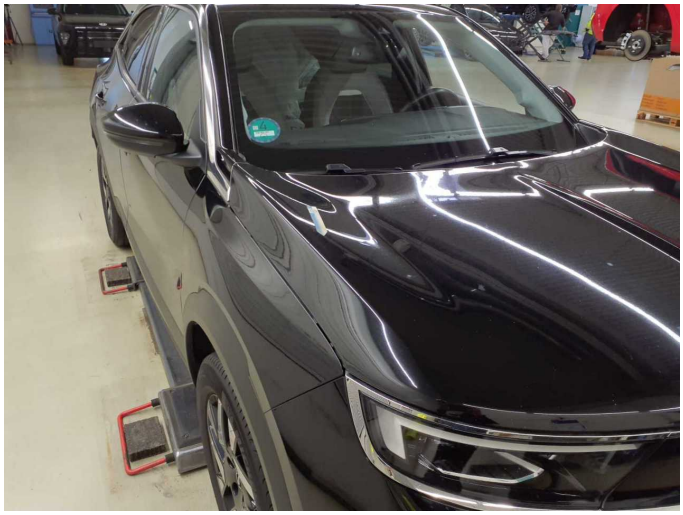
Damage 9: Bonnet: Bonnet - Scratch(es) - Repair and paint

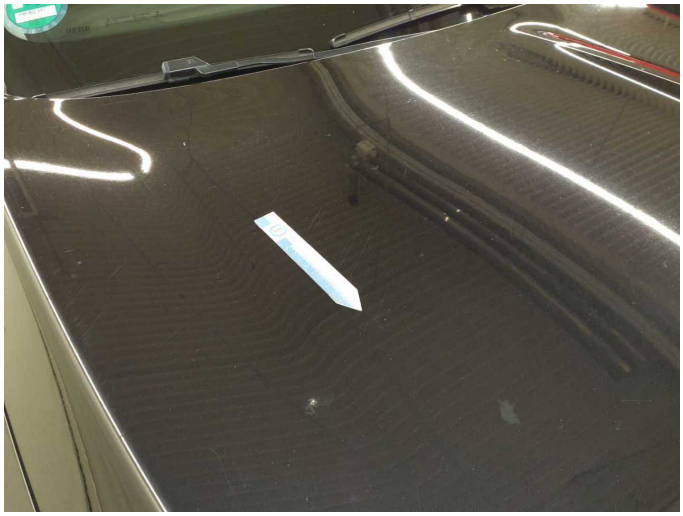
Damage 9: Bonnet: Bonnet - Scratch(es) - Repair and paint

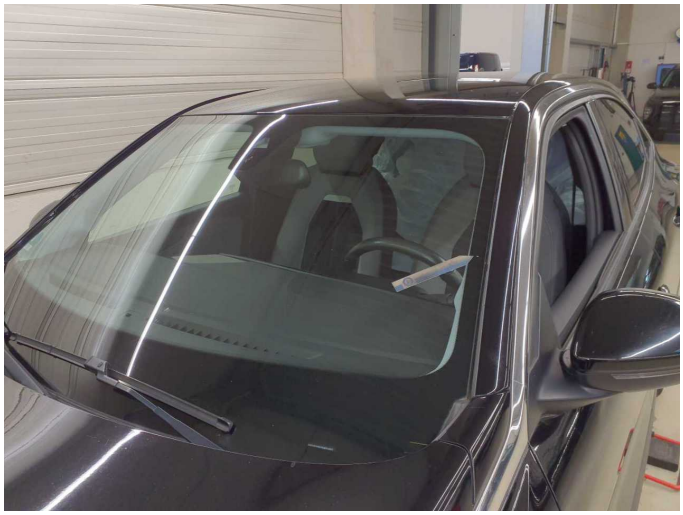
Damage 9: Bonnet: Bonnet - Scratch(es) - Repair and paint

Damage 10: Vehicle glazing: Windscreen - Stone chips - Replace

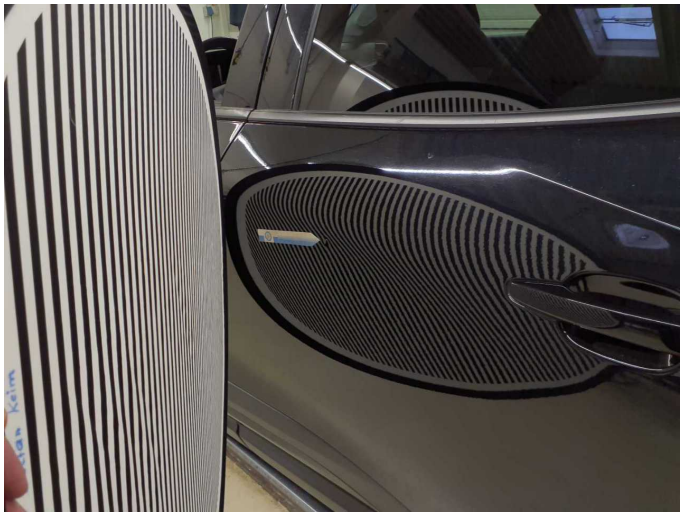
Wear and tear 1: Door - rear left side: Door - dent(s) - No deduction
