Expertise

Protocol number: 48497199
Order No. / Reference: 27236205
Inspection date: 3 Nov 2026

Manufacturer: Volkswagen	Model: Tiguan 1.4 eHybrid OPF DSG R-Line
VIN: WVGZZZ5N6PW409869

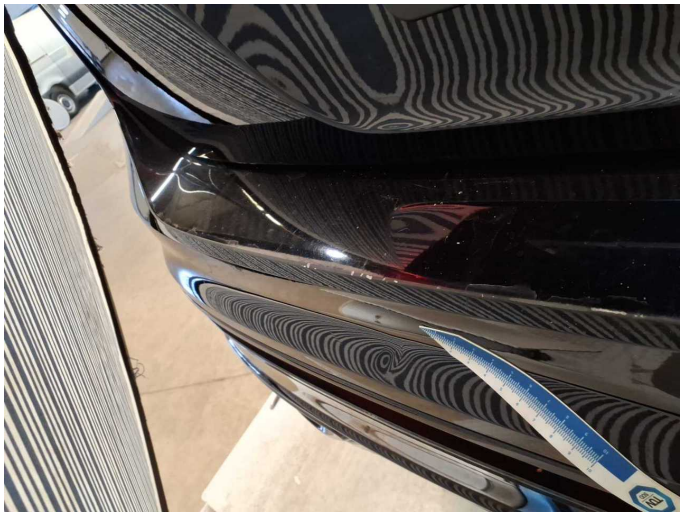
Damage 8: Rear bumper: Rear bumper - Deformed - Repair and paint

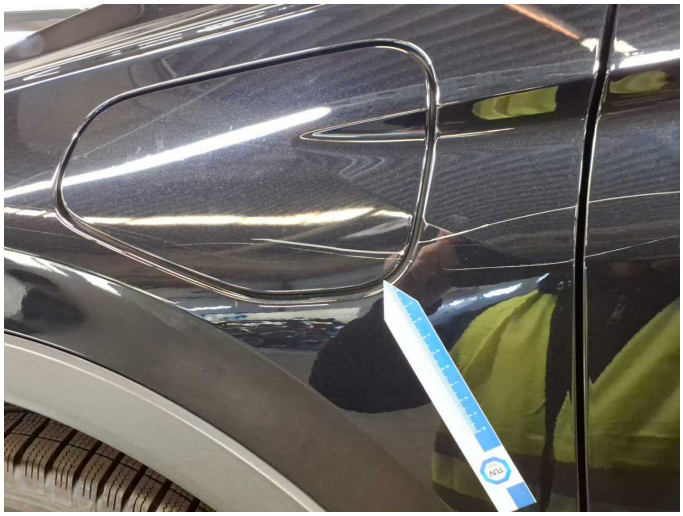
Accident 2: Side - left

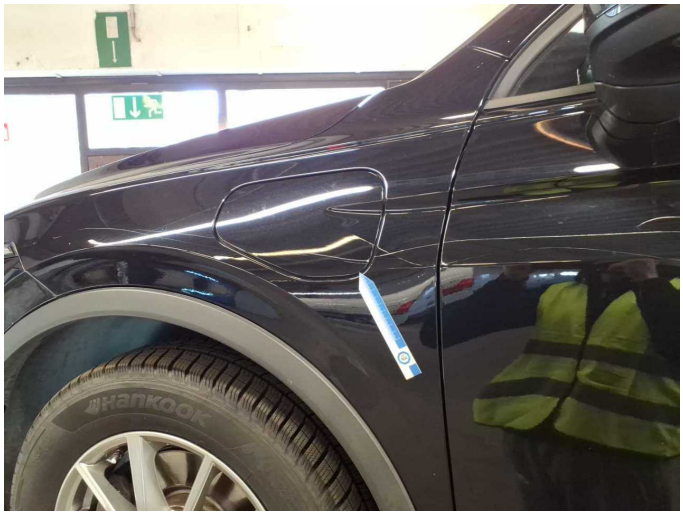
Accident 2: Side - left
