Expertise

Protocol number: 48443647
Order No. / Reference: 27218668
Inspection date: 28 Oct 2026

Manufacturer: Ford	Model: Kuga 2.5 Duratec PHEV VIGNALE
VIN: WF0FXXWPMHPC24409

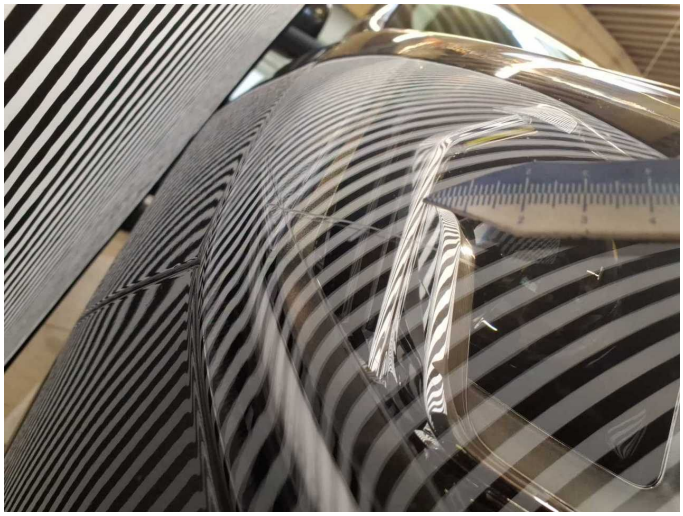
Damage 5: Headlight: Headlight - right side (Tief) - Scratch(es) - Replace

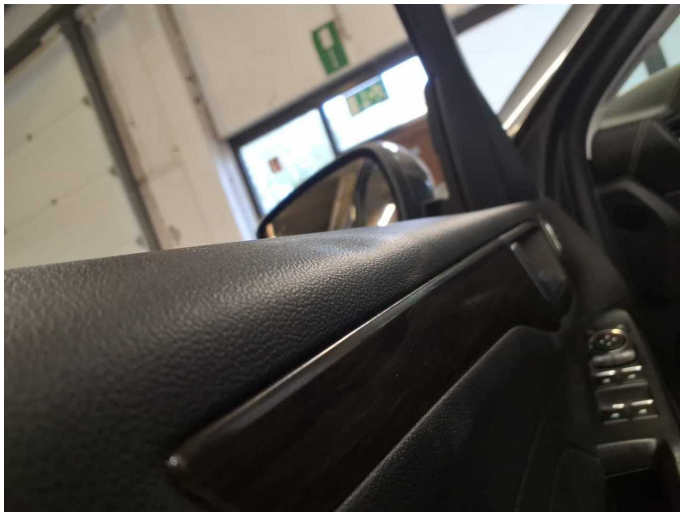
Wear and tear 2: Trim / covers: Door trim - front left side - Deformed - No deduction

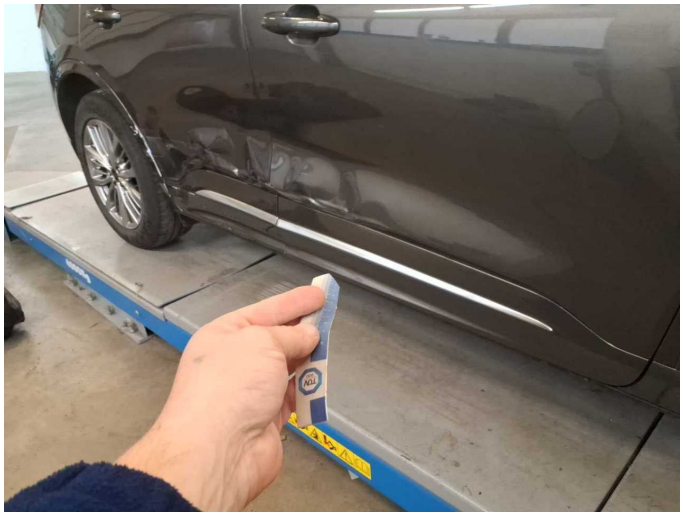
Accident 1: Side right

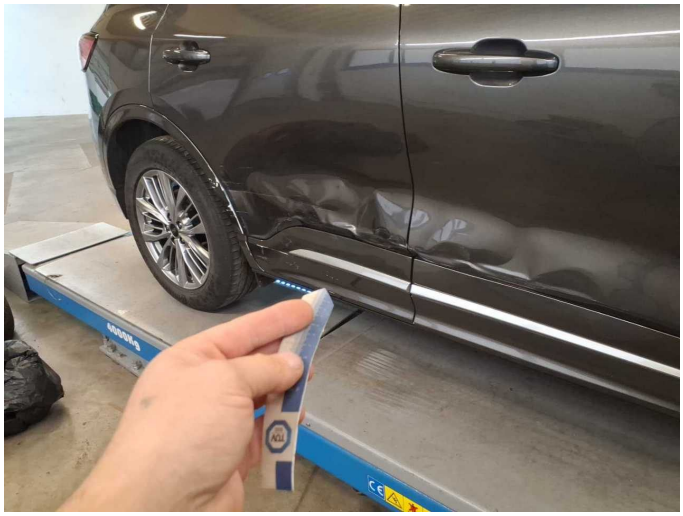
Accident 1: Side right

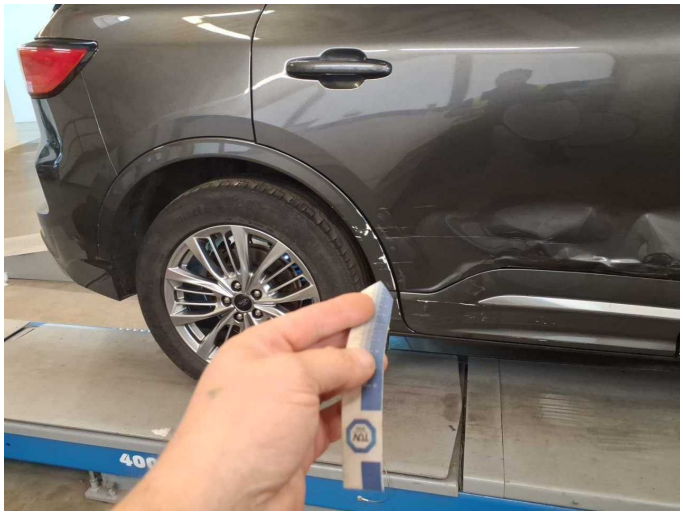
Accident 1: Side right

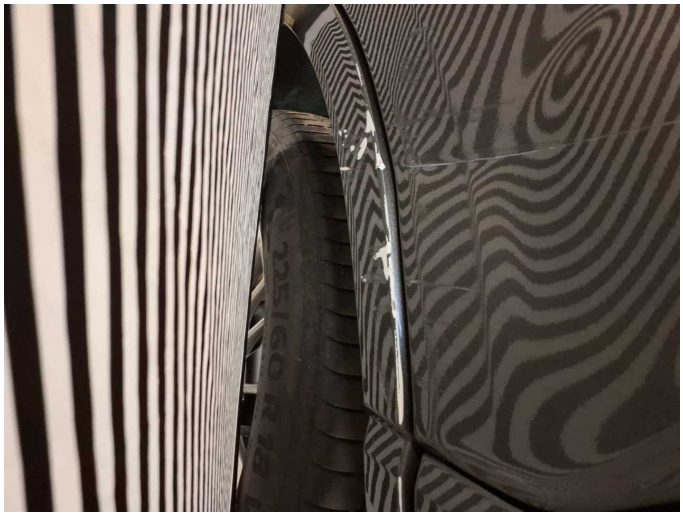
Accident 1: Side right

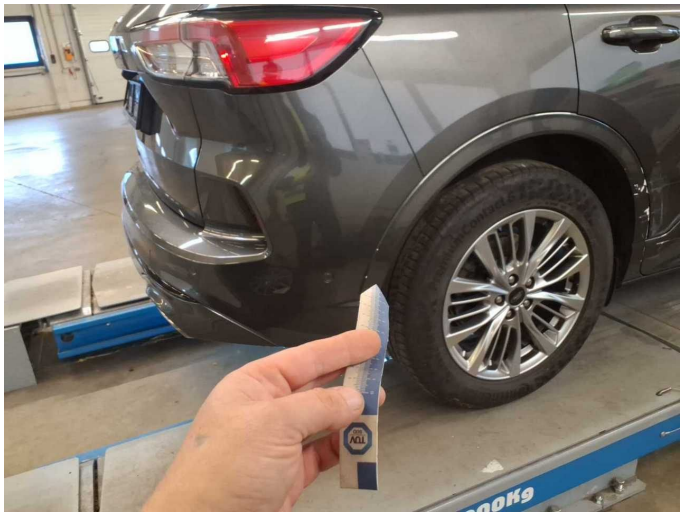
Accident 1: Side right

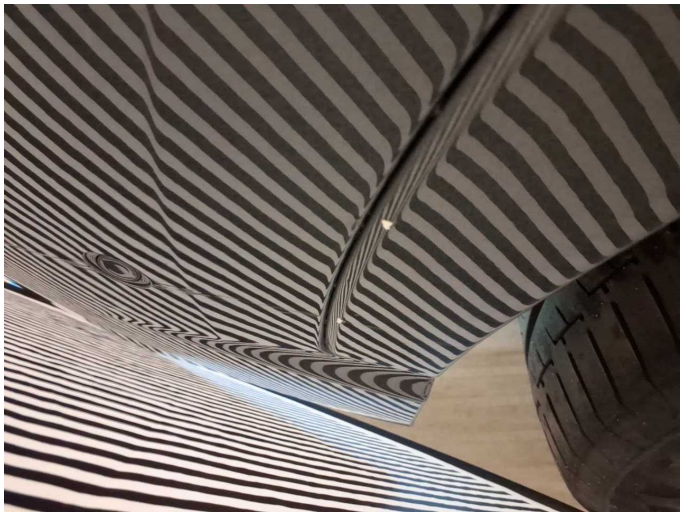
Accident 1: Side right

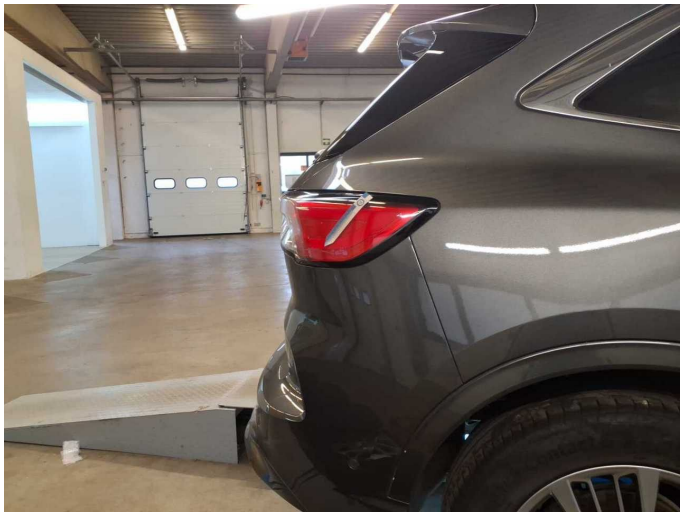
Accident 1: Side right
