Expertise

Protocol number: 48127745
Order No. / Reference: 27025027
Inspection date: 14 Oct 2026

Manufacturer: Volvo	Model: XC60 B5 D AWD Geartronic RDesign
VIN: YV1UZK2VCN1940609

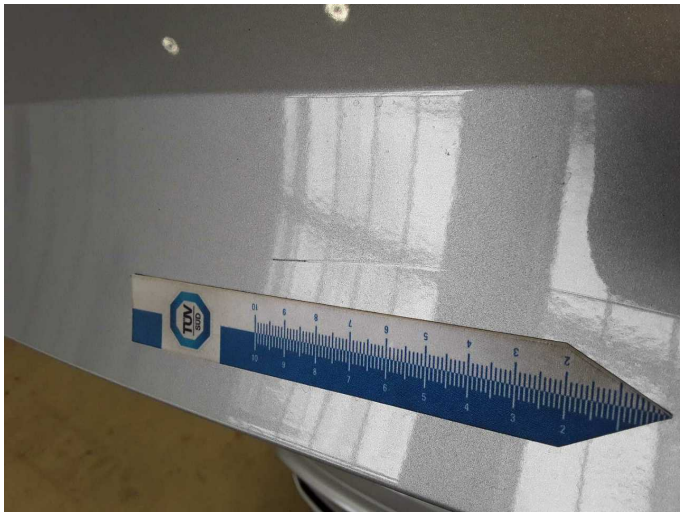
Damage 4: Boot lid / rear door: Boot lid - Scratch(es) - Smart repair
