Expertise

Protocol number: 48459134
Order No. / Reference: 27227354
Inspection date: 2 Nov 2026

Manufacturer: Ford	Model: Focus Turnier 1.5 EcoBlue Start-Stopp-System Aut. TITANIUM
VIN: WF0PXXGCHPPS17072

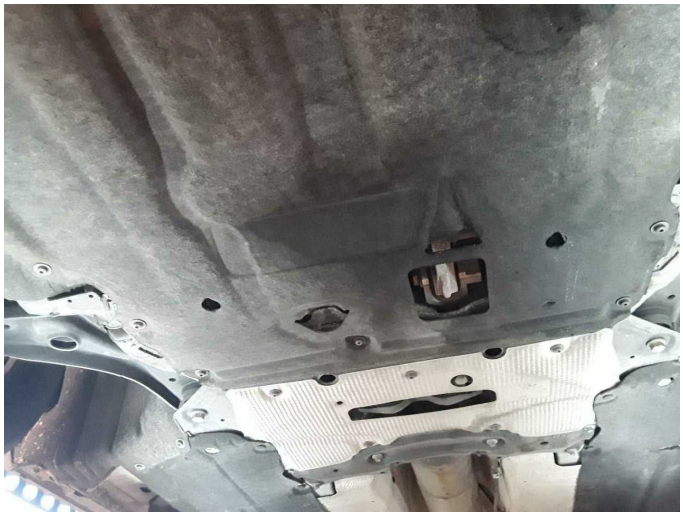
Damage 2: Engine: Engine - Leaking - Perform diagnosis

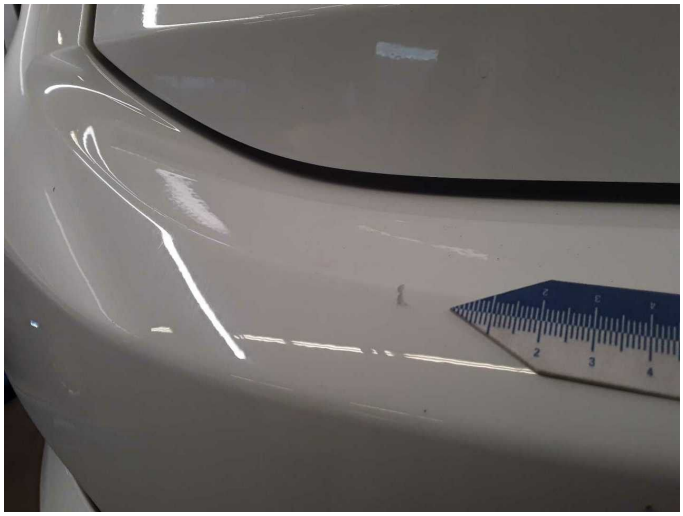
Damage 4: Rear bumper: Rear bumper - Scratch(es) - Paint
