Expertise

Protocol number: 48407468
Order No. / Reference: 27211095
Inspection date: 28 Oct 2026

Manufacturer: Volkswagen	Model: Transporter T6.1 Kurz
VIN: WV1ZZZ7H8PX027113

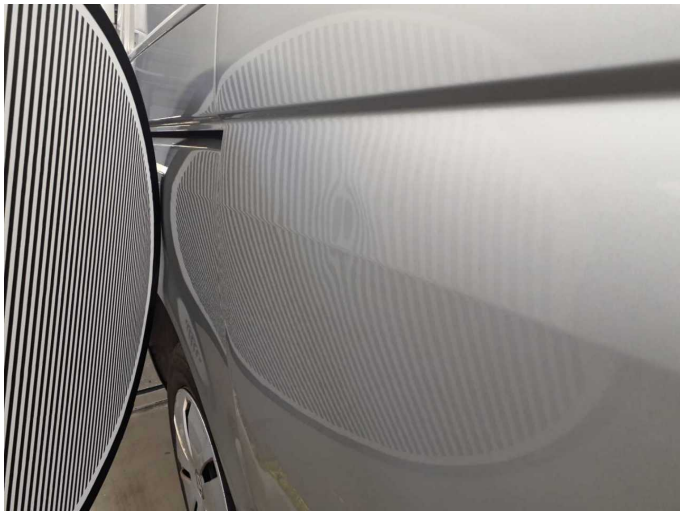
No.	Component group	Description
1	Sliding door, right	Sliding door - dent(s) - Smooth repair work
2	Door - front right side	Door - dent(s) - Smooth repair work
3	Side panel - rear left side	Side panel - dent(s) - Smooth repair work

Damage 1: Sliding door, right: Sliding door - dent(s) - Smooth repair work

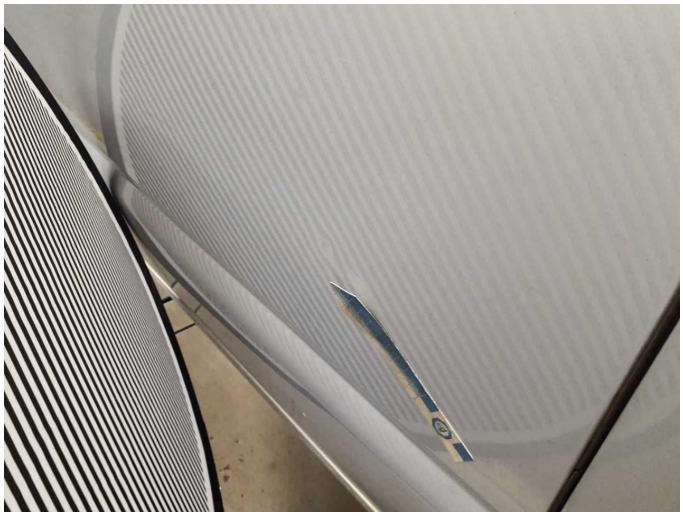
Damage 1: Sliding door, right: Sliding door - dent(s) - Smooth repair work

Damage 2: Door - front right side: Door - dent(s) - Smooth repair work

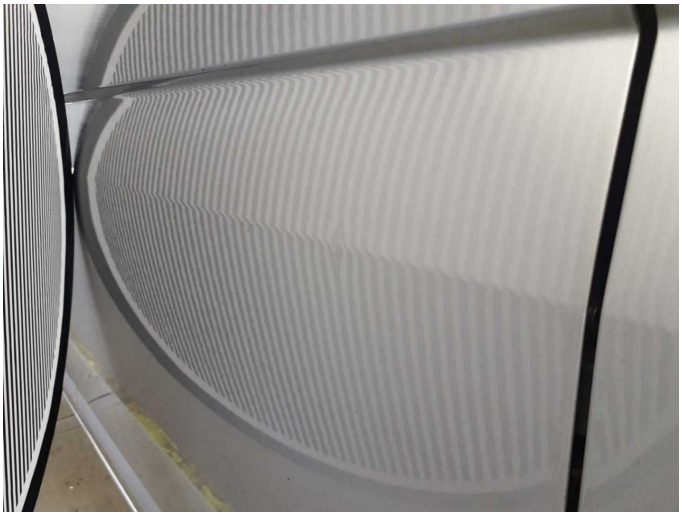
Damage 2: Door - front right side: Door - dent(s) - Smooth repair work

Damage 3: Side panel - rear left side: Side panel - dent(s) - Smooth repair work

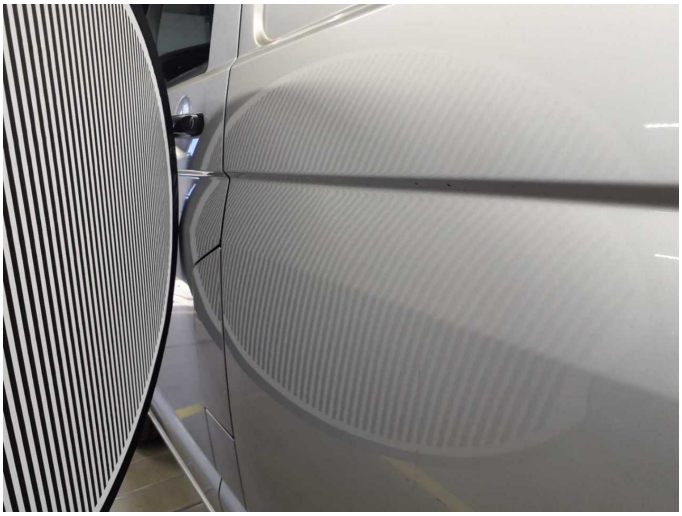
Damage 3: Side panel - rear left side: Side panel - dent(s) - Smooth repair work

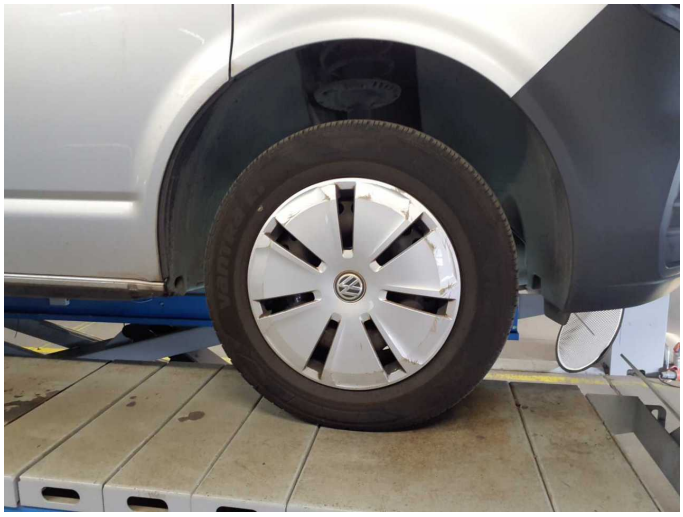
No.	Component group	Description
1	Wheel / tyres	Wheel cover - front right side - Scratched - No deduction

Wear and tear 1: Wheel / tyres: Wheel cover - front right side - Scratched - No deduction
