APPRAISAL REPORT

Make:	VOLKSWAGEN
Model / version:	TOURAN
Wine:	WVGZZZ1TZNW017637
Plate:	2CJB383
Mileage:	131632
First registration:	05/08/2022
Color:	reflex silver

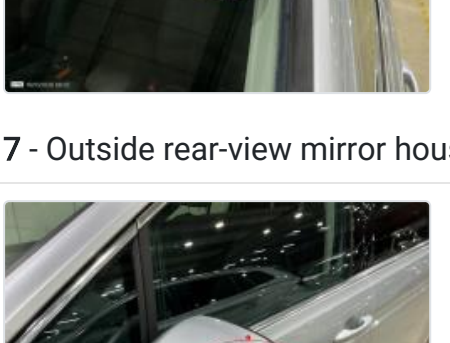
7 - Outside rear-view mirror housing L - Scratch(es)

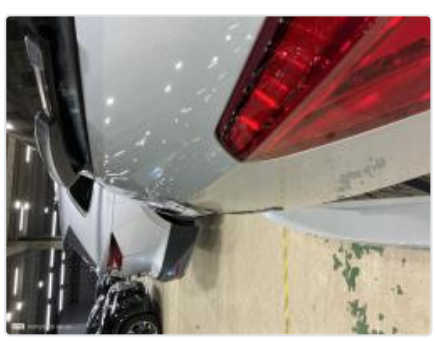
9 - Tailgate / Boot - Tooth(s)
