Expertise

Protocol number: 48087986
Order No. / Reference: 27150367
Inspection date: 13 Oct 2026

Manufacturer: Seat	Model: Ateca 2.0 TDI Xperience
VIN: VSSZZZ5F1P6564664

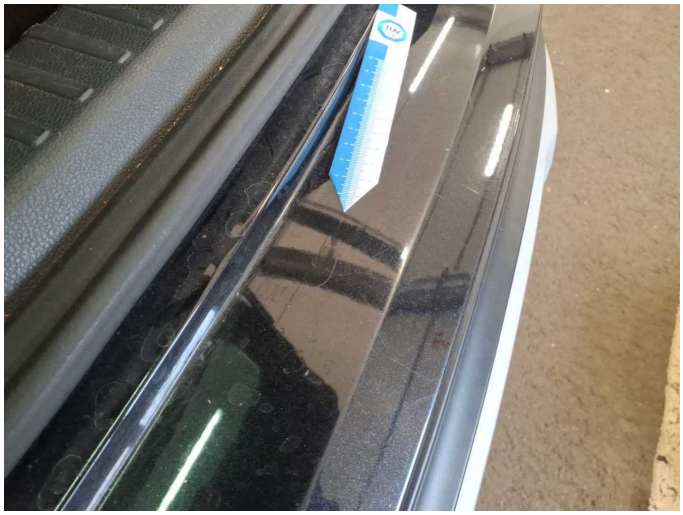
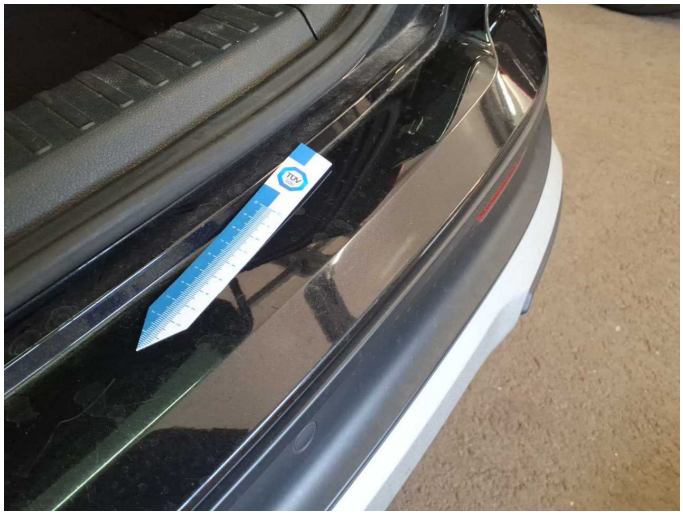
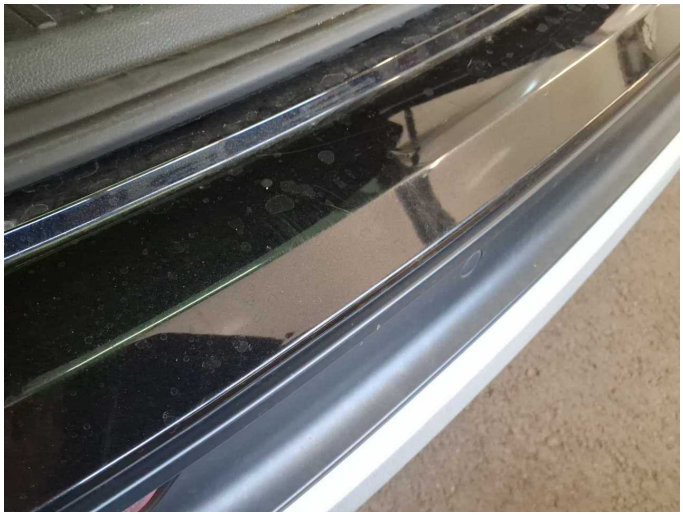
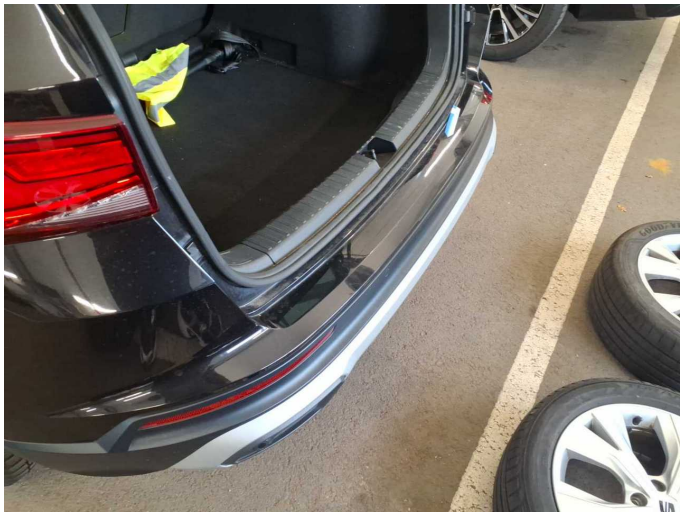
Damage 2: Rear bumper: Rear bumper - Scratch(es) - Paint

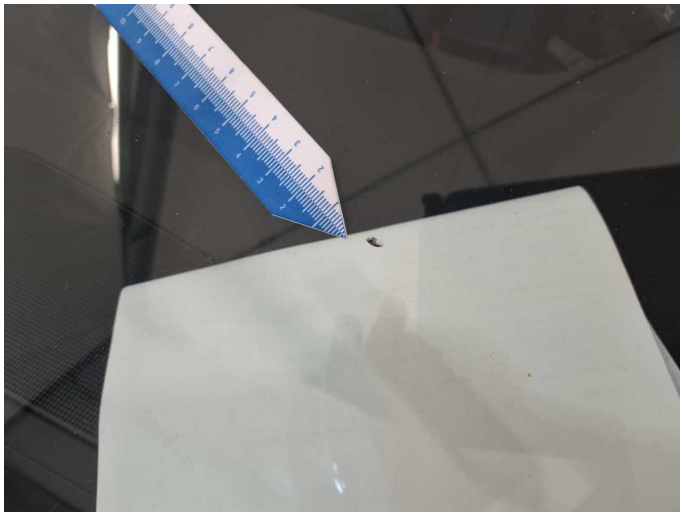
Damage 3: Vehicle glazing: Windscreen (Steinschlag im Sichtfeld) - Stone chips - Replace
