Expertise

Protocol number: 48356596
Order No. / Reference: 27114406
Inspection date: 28 Oct 2026

Manufacturer: Opel	Model: Vivaro 1.5 D Cargo M
VIN: VXEVBYHVMP7819282

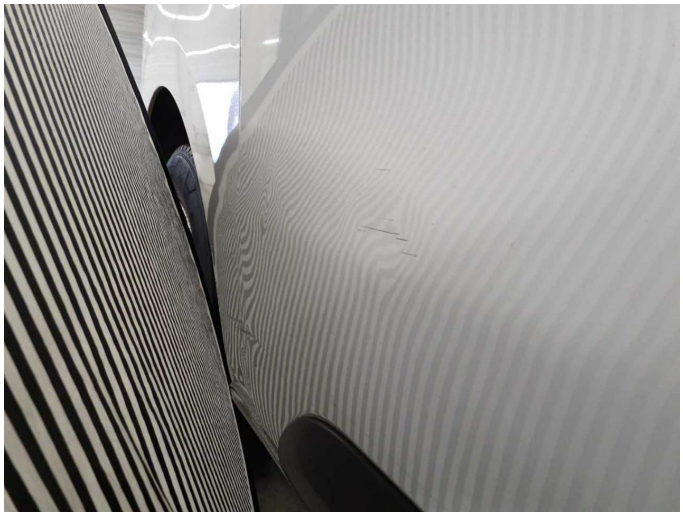
No.	Accident
1	Side right

Seitenwand rechts im Unfall nur Teilweise berechnet.

Accident 1: Side right
