Macadam Austria GmbH
Europaplatz 2/1/2
1150 Wien

Inspection date: 25 Sept 2026
Protocol number: **47774743**

WBA31BL060WX00987

Zustandsbericht

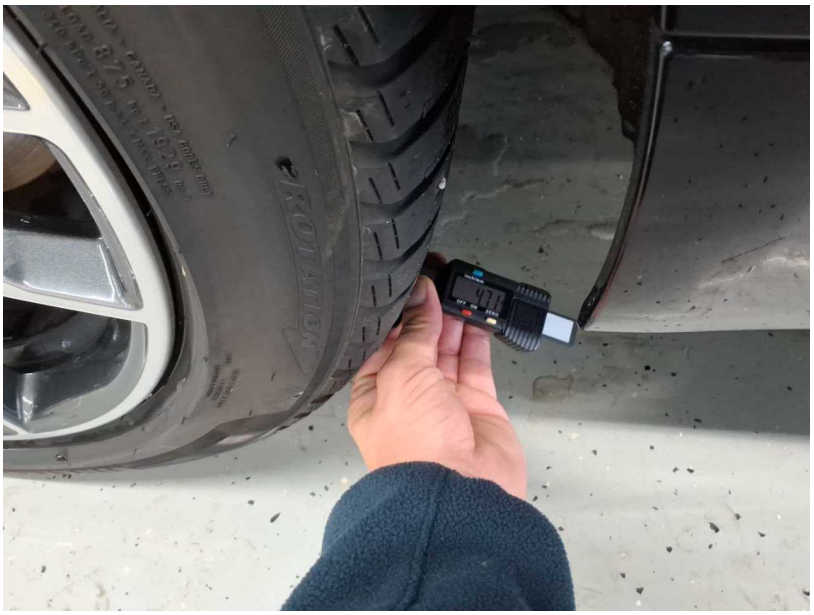
Damage Wheel / tyres: Wheel / tyres: Alloy rim - front right side - Scratched - Smooth repair work

Damage Wheel / tyres: Wheel / tyres: Tyre - right

(Winter unter 5,5mm) - Does not meet the leasing specifications - Replace

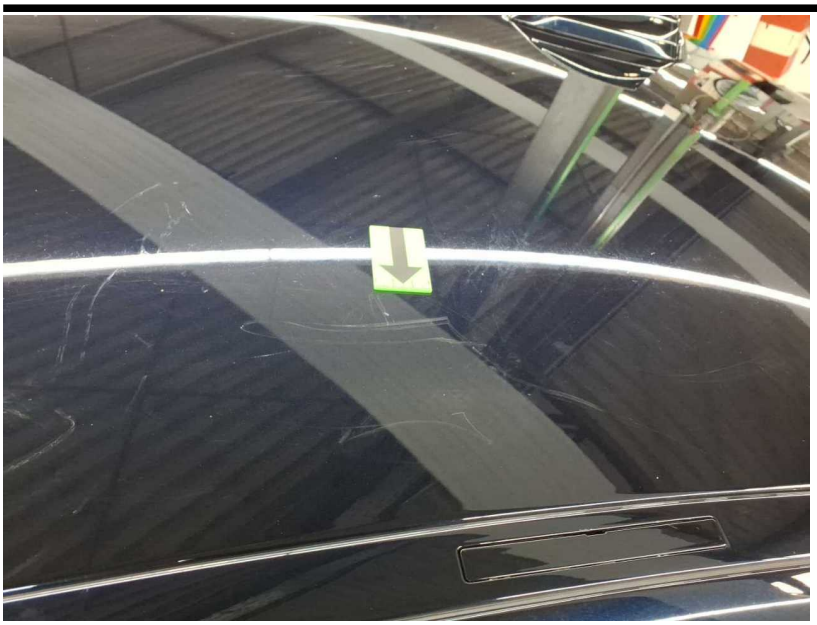
Damage Front bumper: Front bumper: Front bumper - Scratch(es) - repair/paint (S3)

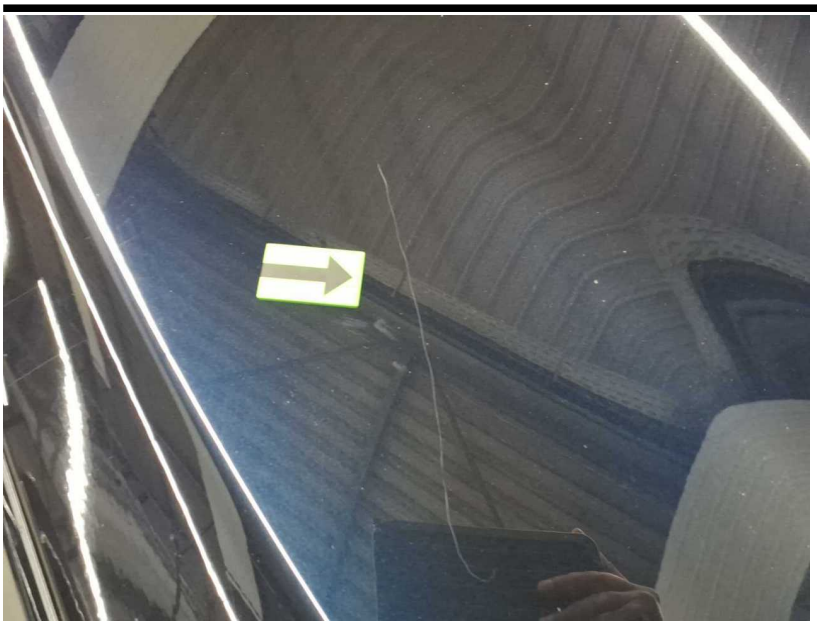
Damage Roof: Roof: Roof - Scratch(es) - repair/ paint (S3)

Damage Roof: Roof: Roof - Scratch(es) - repair/paint (S3)

Damage Bonnet: Bonnet: Bonnet - Scratch(es) - repair/paint (S3)
