Audi

VIN: WAUZZZF39N1036030

Statement details

Inspection loc PARC HÖDLMAYR TONGEREN	**Statement date** 21/10/2026	**Inspection approval date** 22/10/2026

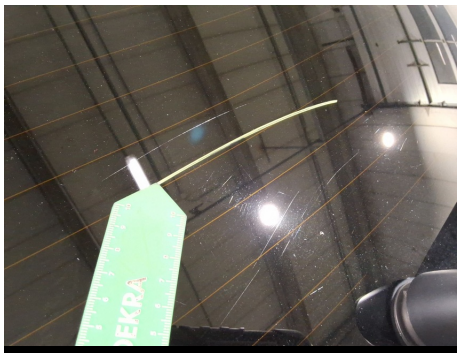
005	Wing / Back Left [1]	Scratched	Acceptable

006	Rear windscreen / - [2] Tinted window : Yes	Scratched	Polishing

Wing / Back Left / Scratched

Rear windscreen / - / Scratched

[1] Polissage

[2] Sur réserve pour échanger

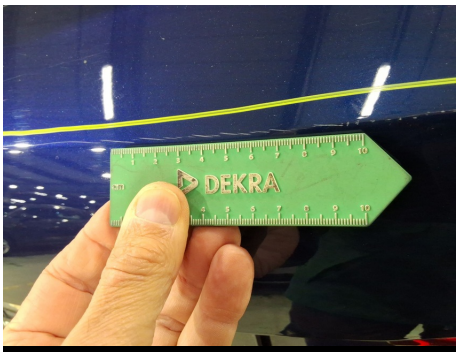
007	Bumper / Back [3] Painted : Yes	Scratched	Acceptable

008	Tailgate / Boot door / -	Scratched	Painting

009	Make badge / -	None	Replace

010	Wing extension moulding / Front Right Painted : Yes	Scratched	Acceptable

011	Roof / - [4]	Scratched	Acceptable

Bumper / Back / Scratched

Tailgate / Boot door / - / Scratched

Make badge / - / None

Wing extension moulding / Front Right / Scratched

Roof / - / Scratched

[3] Polissage

[4] Polissage
