Expertise

Protocol number: 47975037
Order No. / Reference: 27104323
Inspection date: 7 Oct 2026

Manufacturer: Volkswagen	Model: Passat Variant 2.0 TDI SCR
VIN: WVWZZZ3CZNE002242

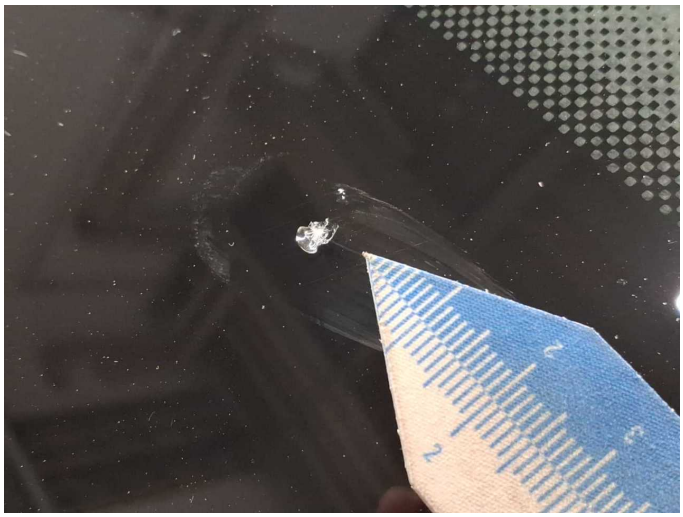
Damage 1: Vehicle glazing: Windscreen - Stone chips - No deduction

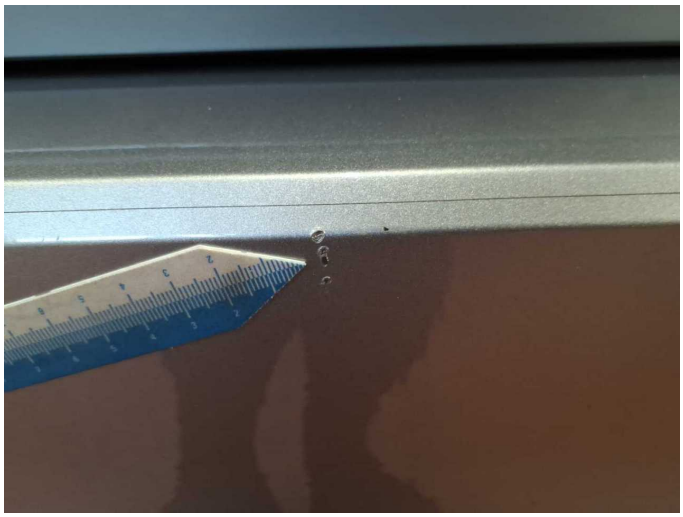
Damage 4: Roof: Roof rail - left side - dent(s) - Smooth repair work

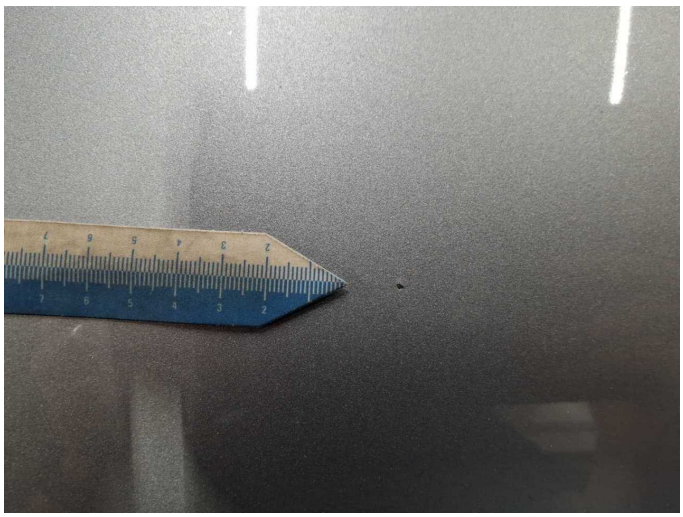
Damage 5: Rear bumper: Rear bumper - Scratch(es) - Smart repair
