Expertise

Protocol number: 48146794
Order No. / Reference: 26979252
Inspection date: 15 Oct 2026

Manufacturer: Volkswagen	Model: Golf Variant 2.0 TDI SCR DSG R-Line
VIN: WVWZZZCD3RW847072

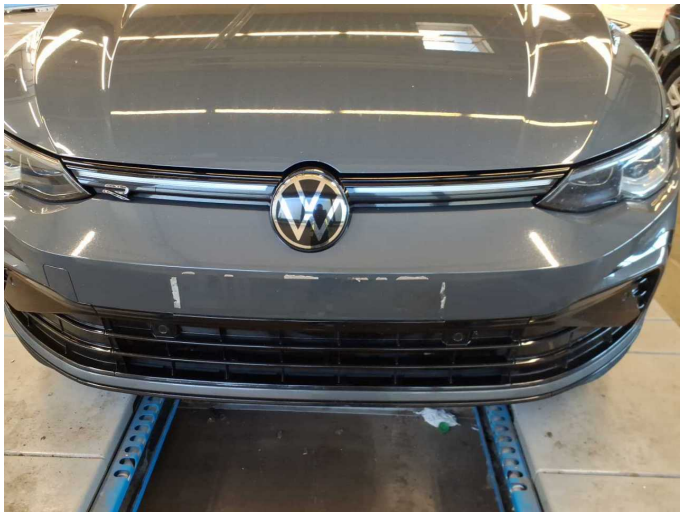
No.	Component group	Description
1	Wheel / tyres	Tyre - rear right side - Broken / torn - Replace
2	Front bumper	Spoiler (Rechts) - Scratch(es) - Replace
3	Wheel / tyres	Alloy rim - rear right side - Scratched - Replace
4	Front bumper	Front bumper (Sandstrahlefekt) - Stone chips - Paint
5	Door - front right side	Door - Scratch(es) - Paint
6	Door - rear right side	Door - Dent / paintcoat damage - Repair and paint

Damage 3: Wheel / tyres: Alloy rim - rear right side - Scratched - Replace
