Expertise

Protocol number: 48028676
Order No. / Reference: 27069491
Inspection date: 8 Oct 2026

Manufacturer: Volkswagen	Model: Passat Variant 2.0 TDI SCR DSG Business
VIN: WVWZZZ3C0RE003777

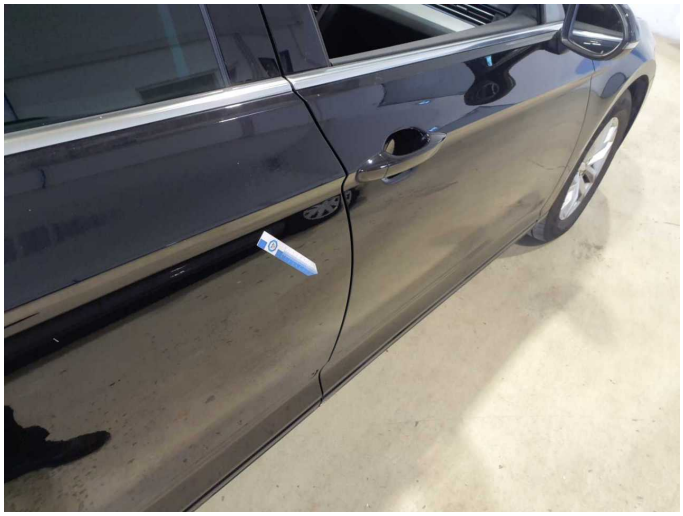
Figure 29: Misc.

Damage 1: Door - rear right side: Door - dent(s) - Smooth repair work

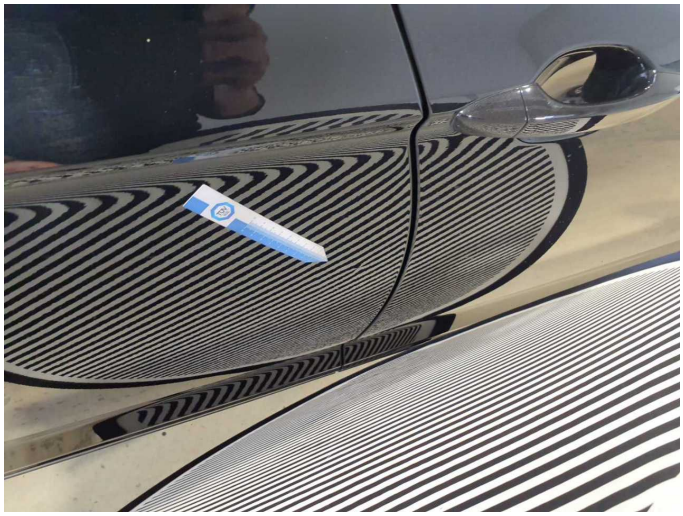
Damage 1: Door - rear right side: Door - dent(s) - Smooth repair work

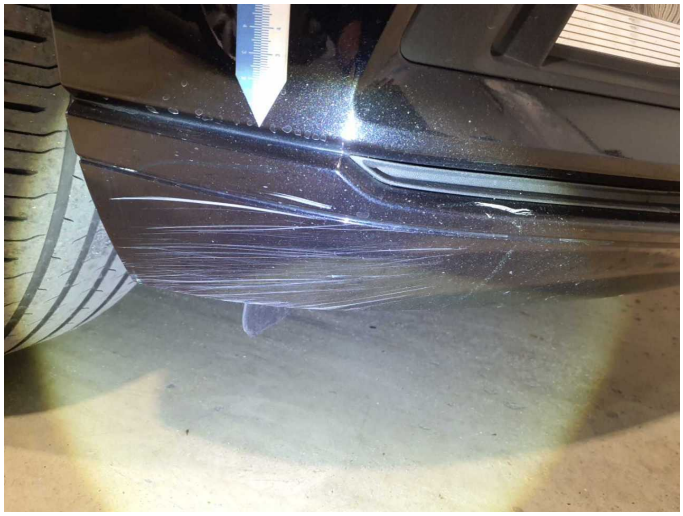
Damage 5: Front bumper: Front bumper - Scratch(es) - Paint

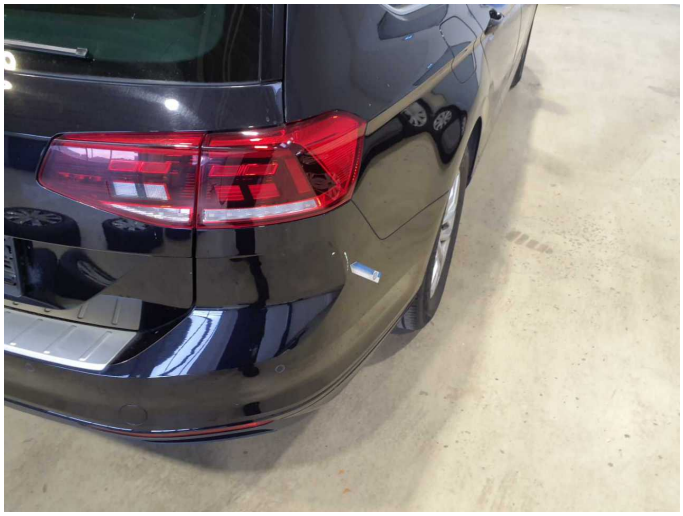
Damage 6: Rear bumper: Rear bumper - Dent / paintcoat damage - Repair and paint

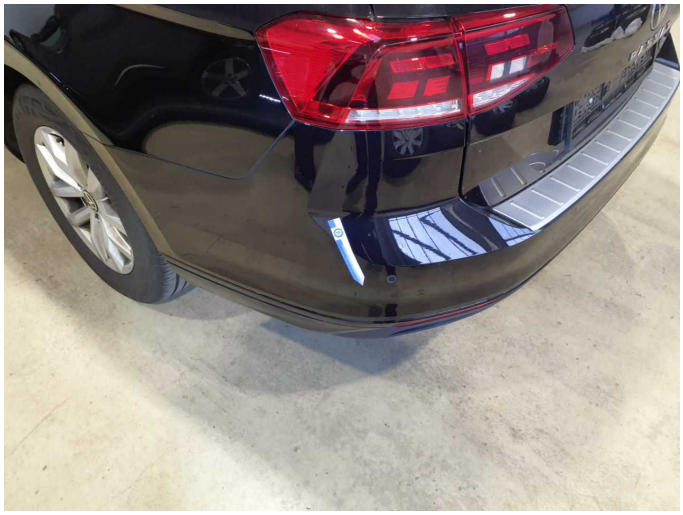
Damage 6: Rear bumper: Rear bumper - Dent / paintcoat damage - Repair and paint
