# Expertise

Protocol number: 48205355
Order No. / Reference: 27053759
Inspection date: 19 Oct 2026

| Manufacturer: Audi | Model: A3 40 TFSI Sportback quattro S tronic S line |

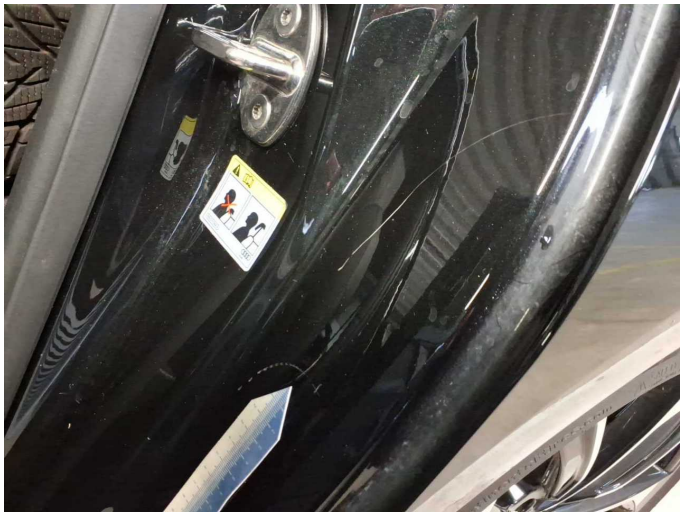
| No. | Component group | Description |
|---|---|---|
| 2 | Side panel - rear left side | Sill - Scratch(es) - Smart repair |

**Damage 2:** Side panel - rear left side: Sill - Scratch(es) - Smart repair

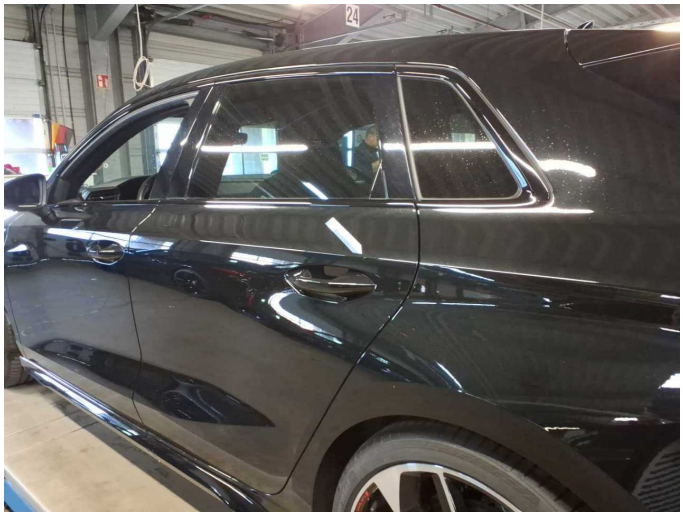
**Damage 2:** Side panel - rear left side: Sill - Scratch(es) - Smart repair

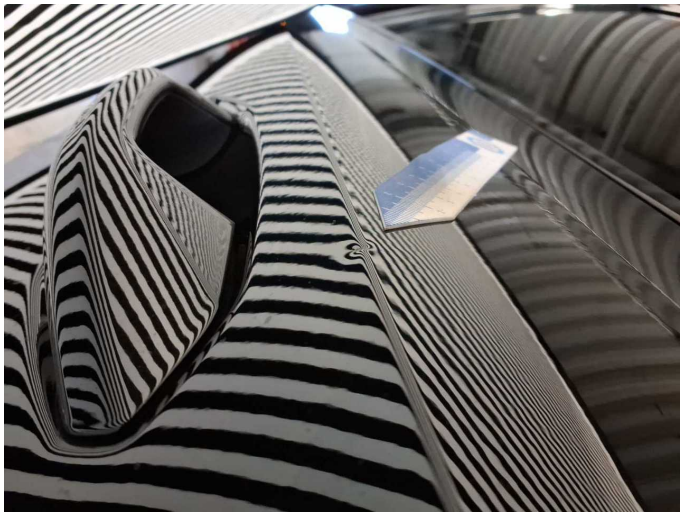
| No. | Component group | Description |
|---|---|---|
| 3 | Door - rear left side | Door (Delle Geht über die Kante) - dent(s) - Paint |

**Damage 3:** Door - rear left side: Door (Delle Geht über die Kante) - dent(s) - Paint

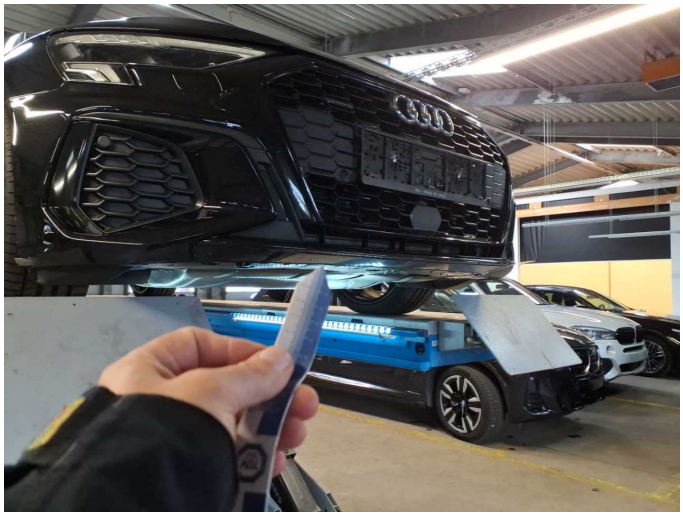
| No. | Component group | Description |
|---|---|---|
| 4 | Front bumper | Front bumper - Scratched - Paint |

**Damage 4:** Front bumper: Front bumper - Scratched - Paint

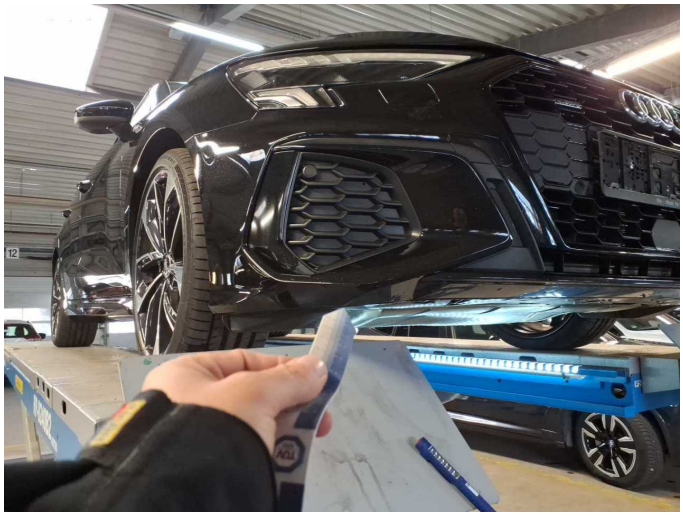
**Damage 4:** Front bumper: Front bumper - Scratched - Paint
