Expertise

Protocol number: 48414978
Order No. / Reference: 27170956
Inspection date: 21 Oct 2026

Manufacturer: Ford	Model: Transit Custom 320 L2H1 LKW VA Trend Kasten
VIN: WF0YXXTTGYNT02657

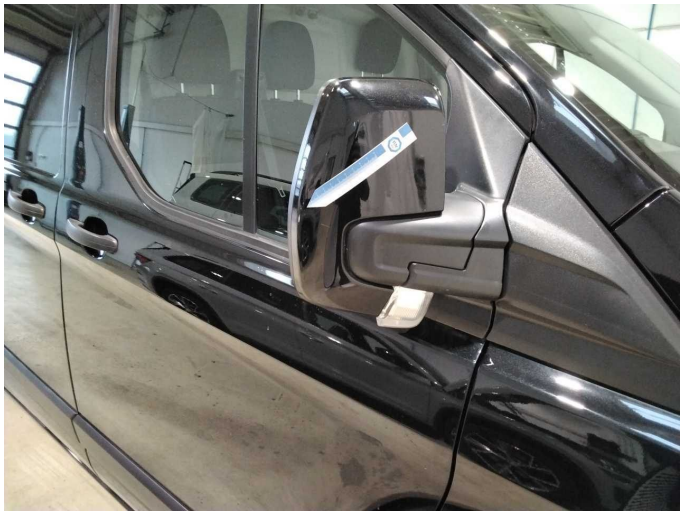
No.	Component group	Description
1	Wing mirror - right side	Cap - Scratch(es) - Smart repair
2	Fuel system	Tank cap - Scratch(es) - Smart repair
3	Sliding door, right	Sliding door - dent(s) - Smooth repair work
4	Body	B-pillar - right side - Scratch(es) - Smart repair
5	Body	B-pillar - left side - Scratch(es) - Smart repair
6	Side panel - rear left side	Side panel - Dent / paintcoat damage - Smooth repair work
7	Front bumper	Front bumper - Broken / torn - Replace

Damage 1: Wing mirror - right side: Cap - Scratch(es) - Smart repair

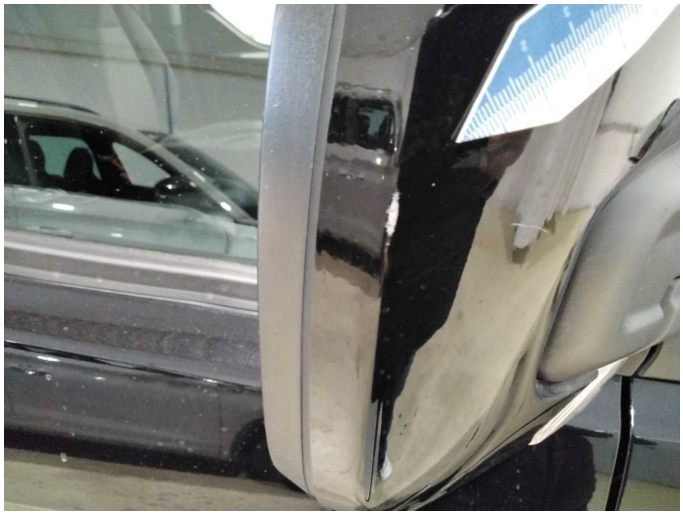
Damage 1: Wing mirror - right side: Cap - Scratch(es) - Smart repair

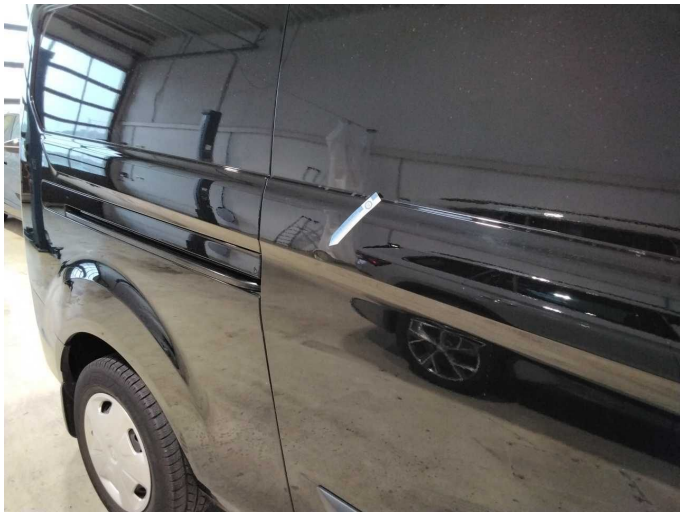
Damage 2: Fuel system: Tank cap - Scratch(es) - Smart repair

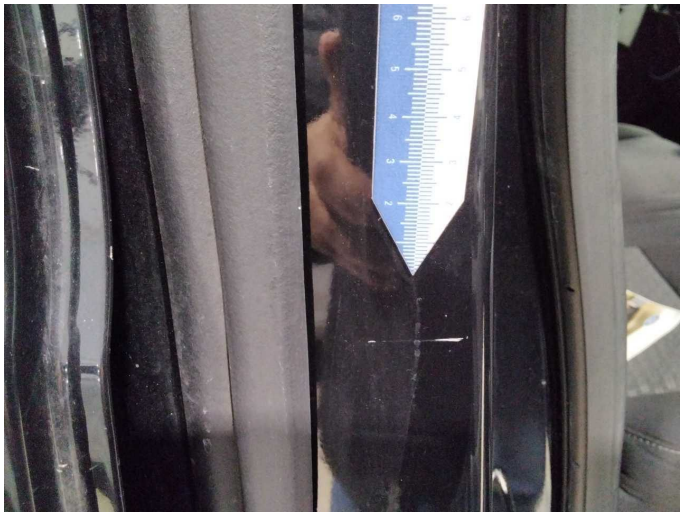
Damage 4: Body: B-pillar - right side - Scratch(es) - Smart repair

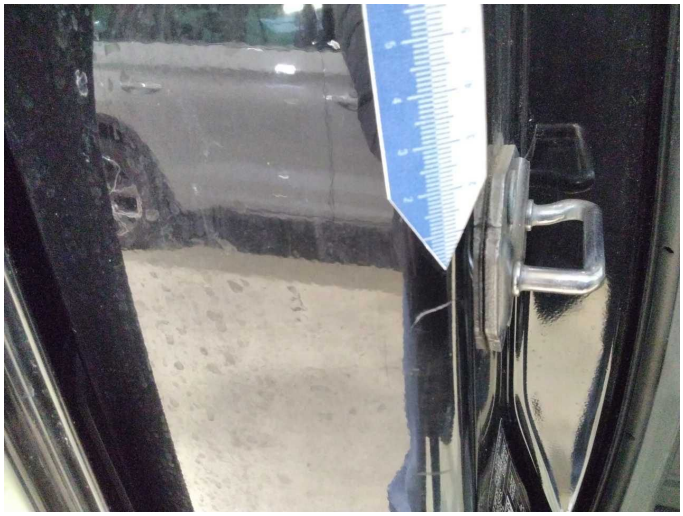
Damage 4: Body: B-pillar - right side - Scratch(es) - Smart repair

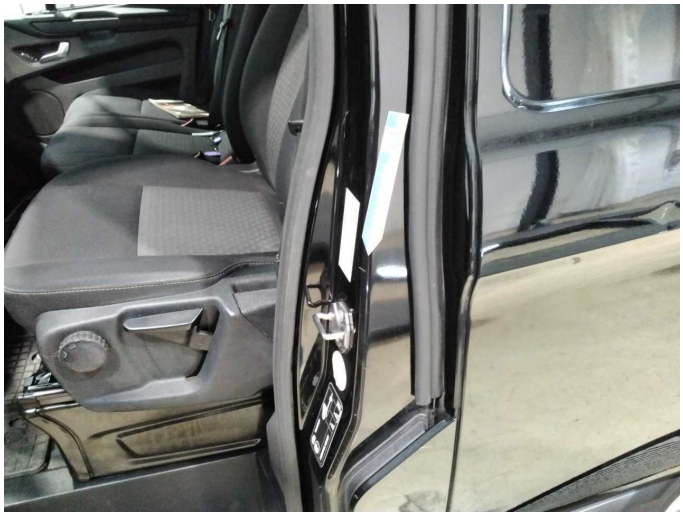
Damage 5: Body: B-pillar - left side - Scratch(es) - Smart repair

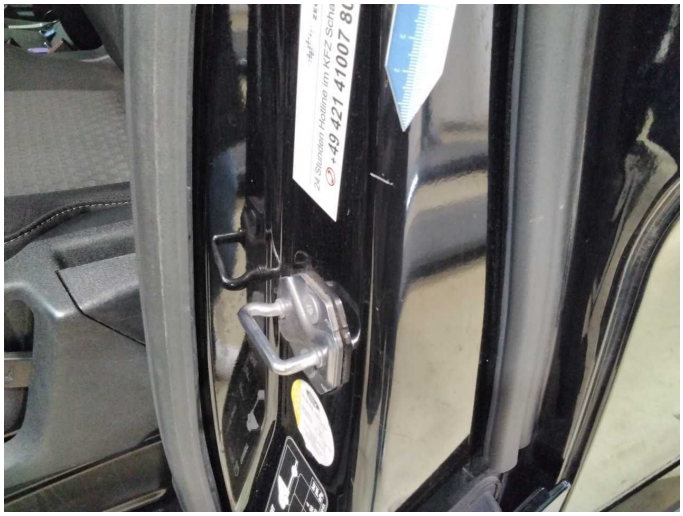
Damage 5: Body: B-pillar - left side - Scratch(es) - Smart repair

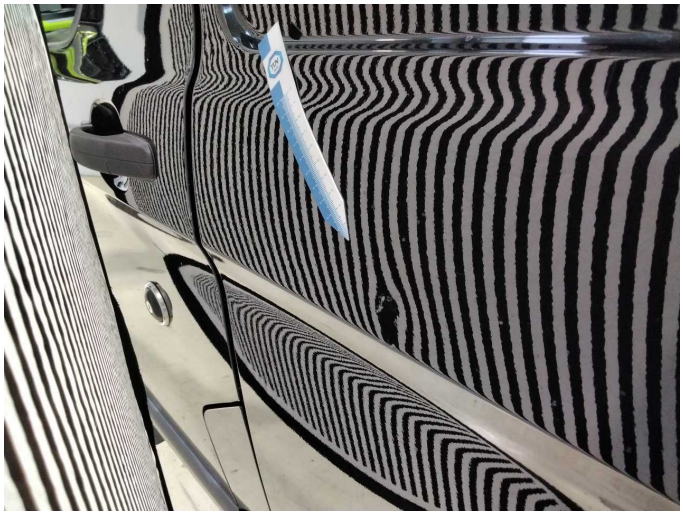
Damage 6: Side panel - rear left side: Side panel - Dent / paintcoat damage - Smooth repair work

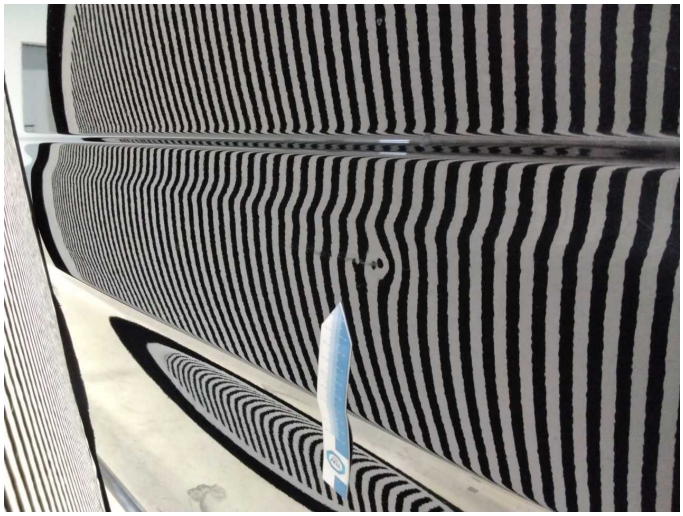
Damage 6: Side panel - rear left side: Side panel - Dent / paintcoat damage - Smooth repair work

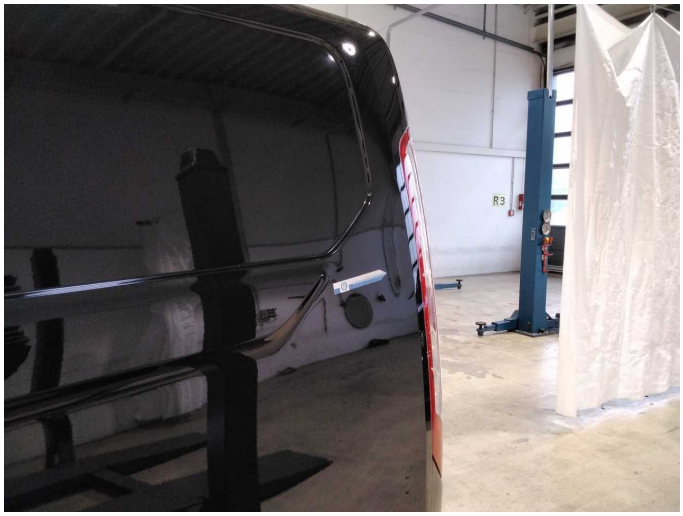
Damage 6: Side panel - rear left side: Side panel - Dent / paintcoat damage - Smooth repair work

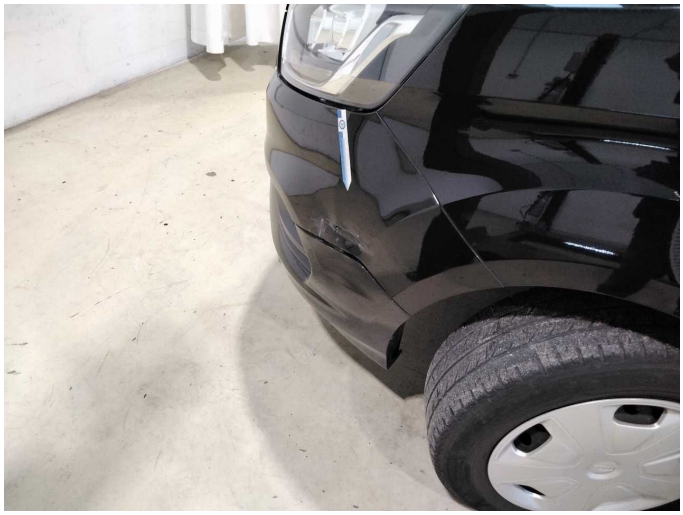
Damage 6: Side panel - rear left side: Side panel - Dent / paintcoat damage - Smooth repair work
