BMW X2

Vehicle information

Damages

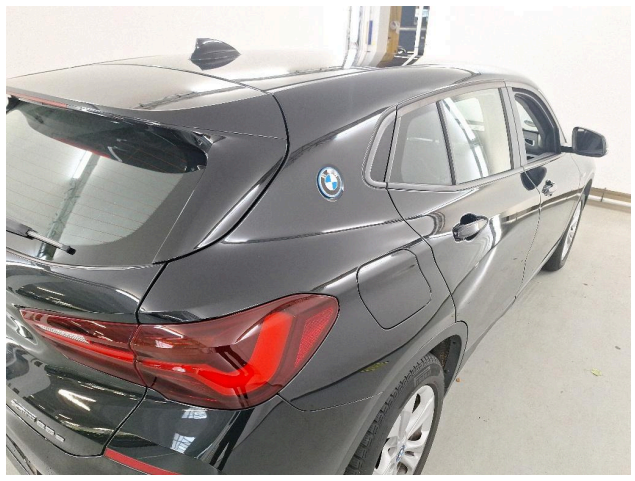
Right rear wing
repaired.
No repairs
.

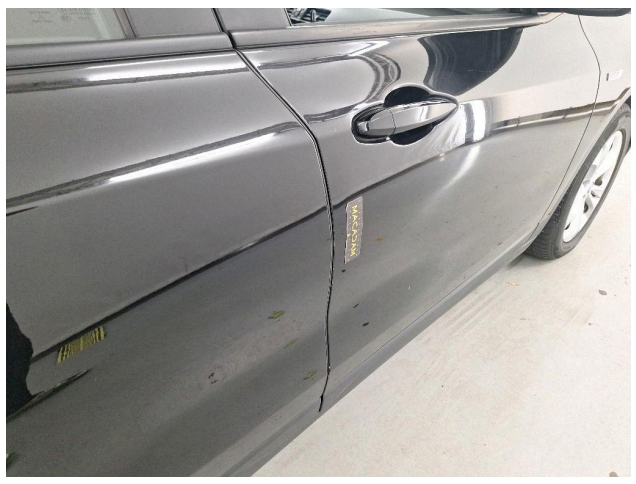
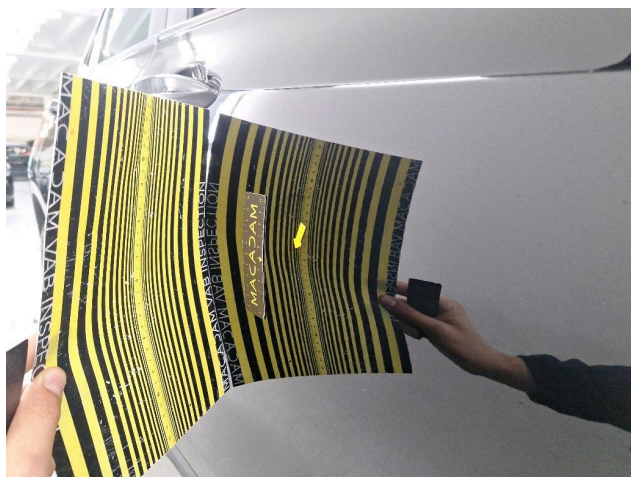
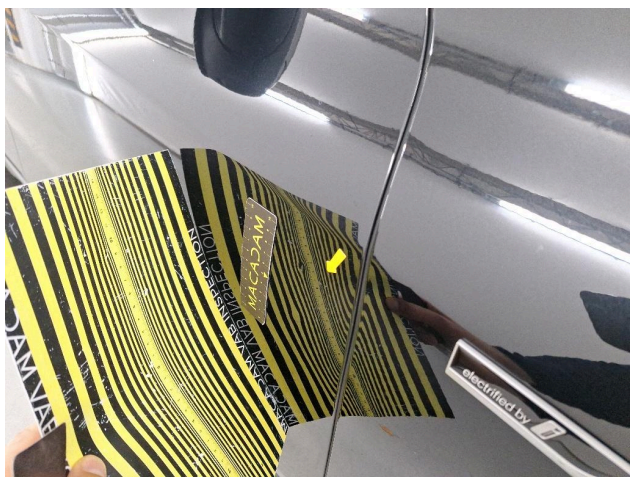
Bodywork
Damaged -
Acceptable.
Roof & other

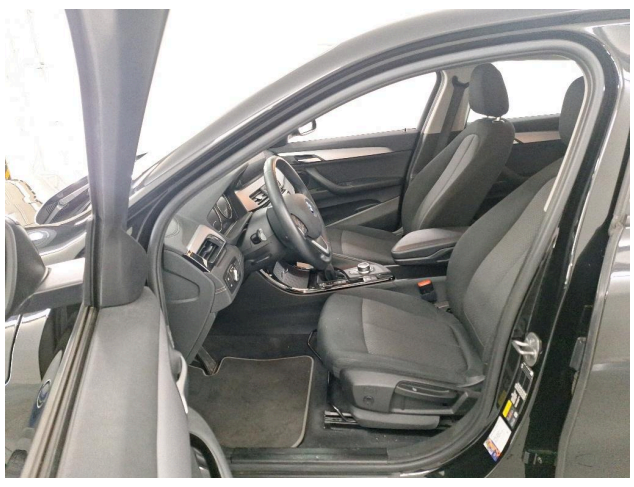
Damaged **Interior**
- Acceptable
Interior

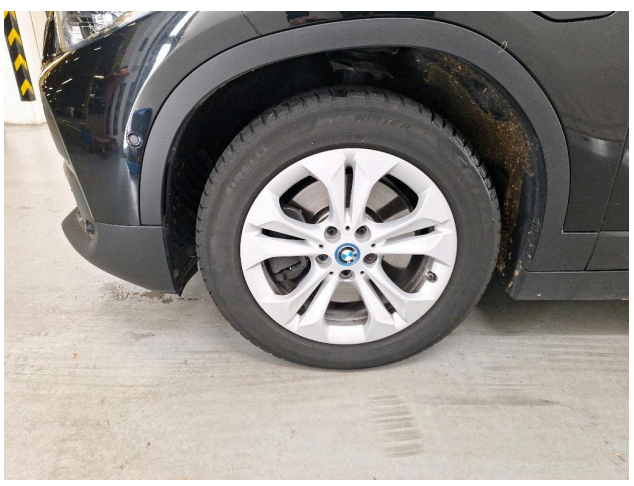
Alloy wheel AVG
Scratch(es)
LI - Repair and paint (complete)
Left

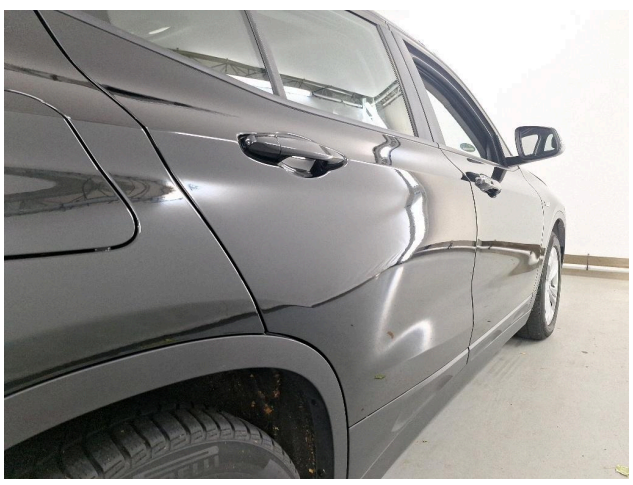
Right rear door
repaired.
No repairs
.

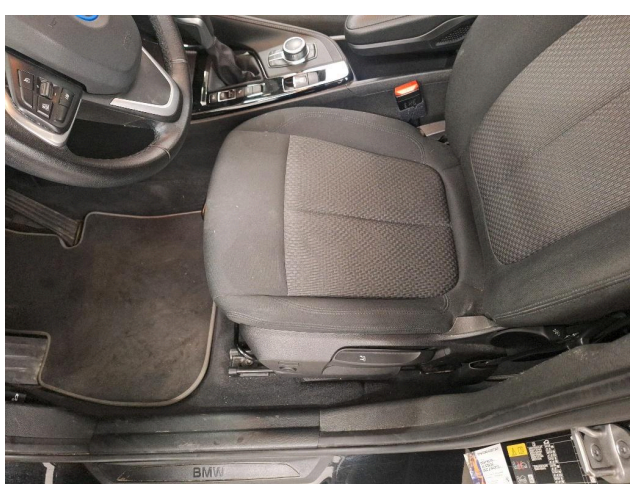
AVG Seat Upholstery
Stain
Clean
Interior
