ARVAL
BNP PARIBAS GROUP

2BQJ759

INSPECTION REPORT

End of contract

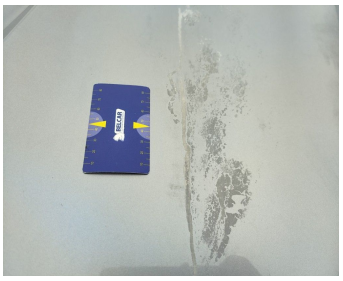
Rocker Panel Right // Smart Repair Medium-dent
