Expertise

Protocol number: 48583772
Order No. / Reference: 27242465
Inspection date: 9 Nov 2026

Manufacturer: Opel	Model: Mokka-e Elegance
VIN: VXKUKZKXZPW047777

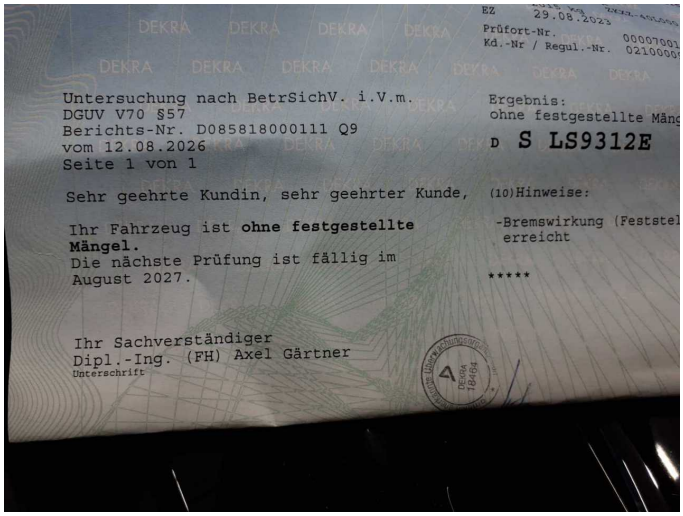
Figure 12: Mounted tyres

#	Tyre size	Type of tyre	Manufacturer	Tread depth
1)	215/60 R17 96H	Winter tyres on Light alloy	Pirelli	5mm / 5mm
2)	215/60 R17 96H	Winter tyres on Light alloy	Pirelli	5mm / 5mm

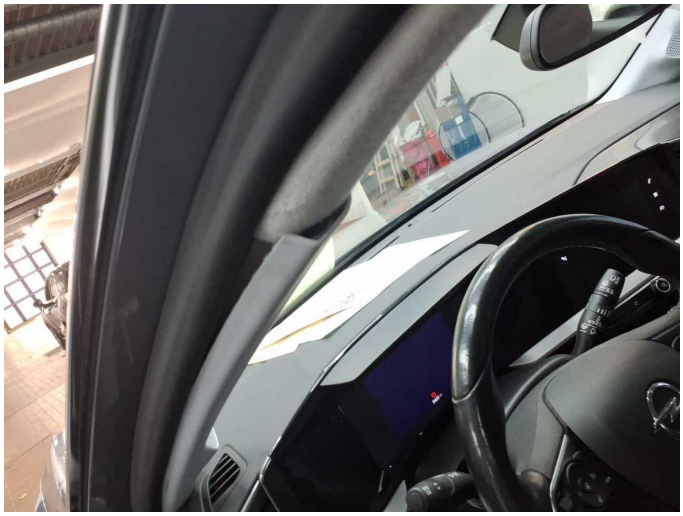
Damage 1: Trim / covers: A-pillar - trim - interior, left side - Loose - Repair

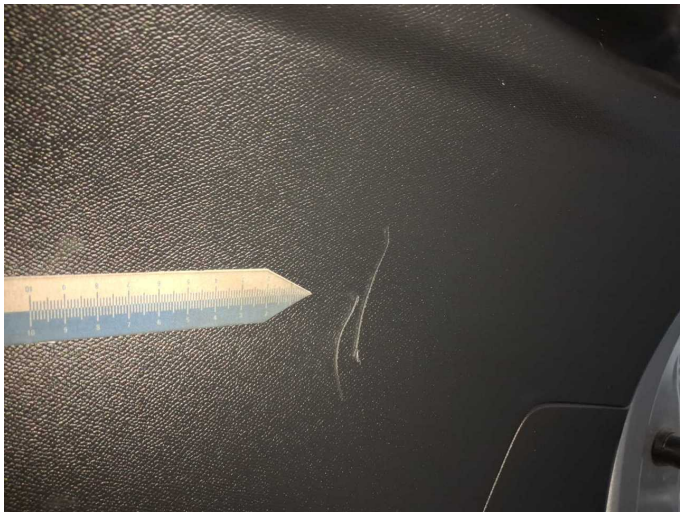
Damage 2: Trim / covers: Boot lid - interior trim - Scratch(es) - Loss in value

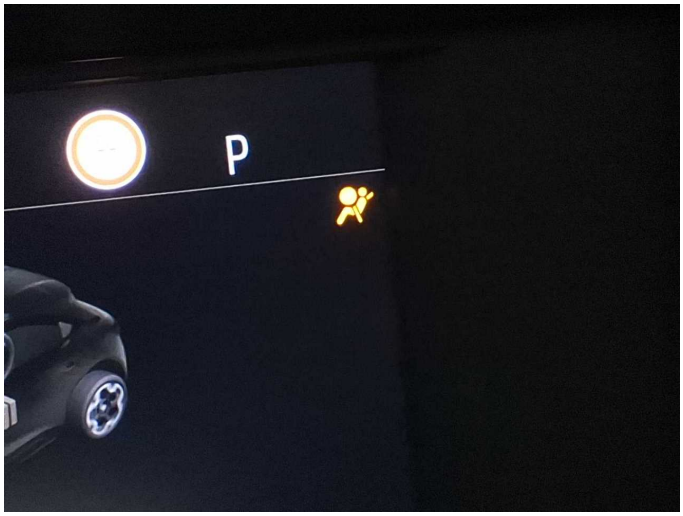
Damage 3: Side panel - rear left side: Wheel arch - Scratched - Replace

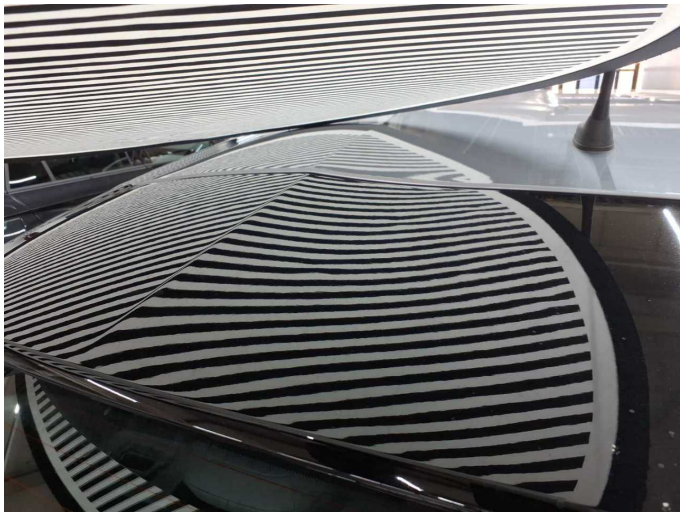
Damage 4: Airbag systems: Airbag system - on - Perform diagnosis

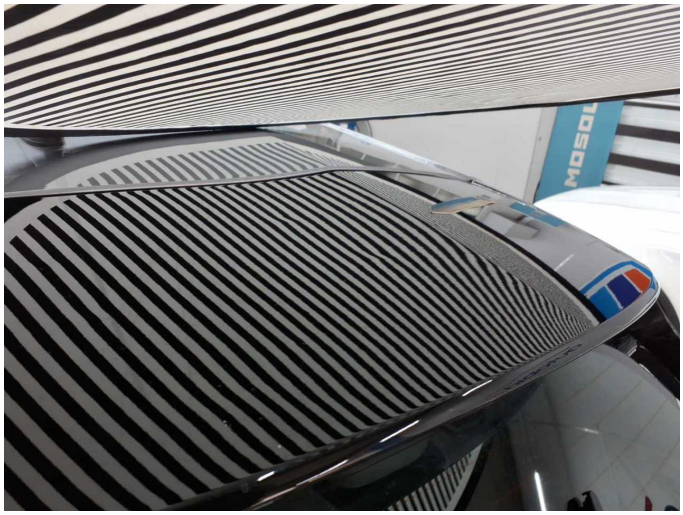
Damage 5: Boot lid / rear door: Rear spoiler - dent(s) - Repair and paint
