Expertise

Protocol number: 48222509
Order No. / Reference: 27014354
Inspection date: 13 Oct 2026

Manufacturer: Volkswagen	Model: Touran 2.0 TDI SCR DSG Highline
VIN: WVGZZZ1T0PW003994

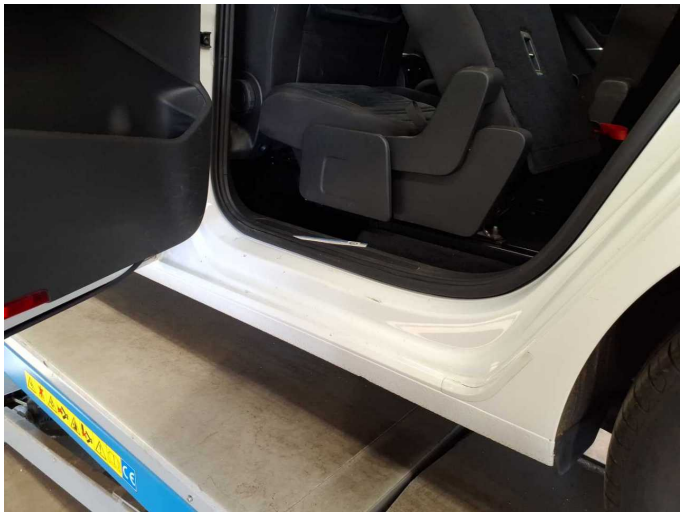
Damage 1: Side panel - rear right side: Side panel - dent(s) - Smooth repair work
