Expertise

Protocol number: 48344819
Order No. / Reference: 27164456
Inspection date: 27 Oct 2026

Manufacturer: Opel	Model: Astra Sports Tourer 1.5 D Business Edition
VIN: VXKFCYHZLP1055743

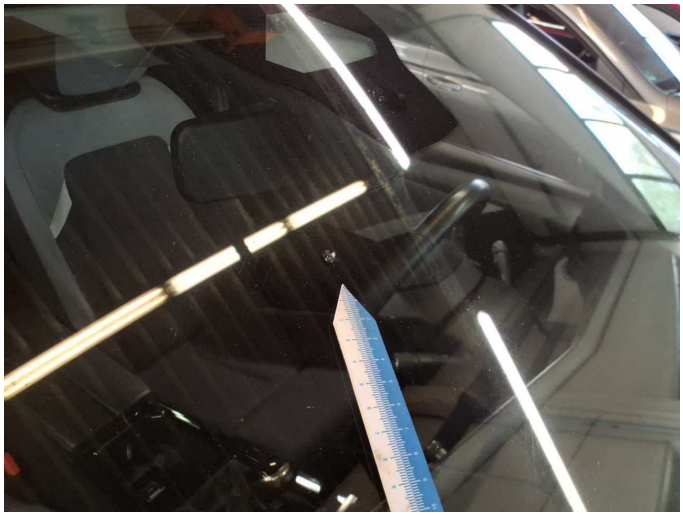
No.	Component group	Description
1	Door - rear left side	Door - Scratch(es) - Smart repair
2	Sill - left side	Sill - Scratch(es) - Smart repair
3	Vehicle glazing	Windscreen - Stone chips - Replace

Damage 3: Vehicle glazing: Windscreen - Stone chips - Replace
