Expertise

Protocol number: 48585457
Order No. / Reference: 27222626
Inspection date: 9 Nov 2026

Manufacturer: Ford	Model: Transit Connect 230 L2 S&S Aut. Trend
VIN: WF0SXXWPGSNJ49531

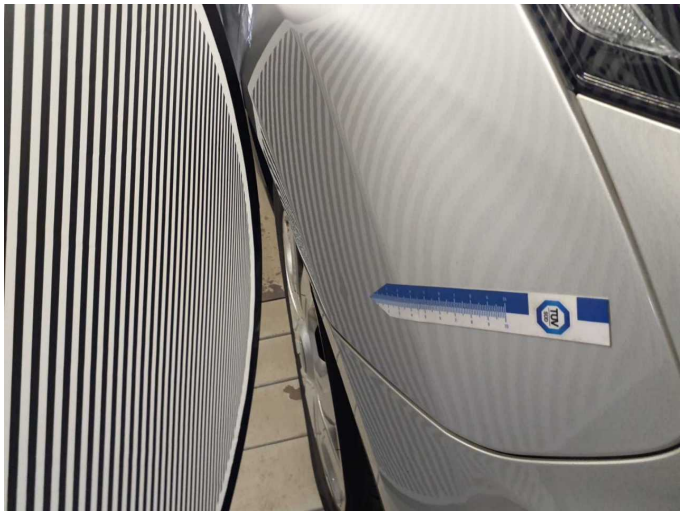
No.	Component group	Description
1	Mudguard - right side	Mudguard - right side - dent(s) - Smart repair
2	Door - front left side	Door - dent(s) - Smart repair
3	Side panel - rear right side	Side panel - dent(s) - Smooth repair work
4	Sliding door, right	Sliding door - dent(s) - Smart repair

Damage 1: Mudguard - right side: Mudguard - right side - dent(s) - Smart repair

Damage 2: Door - front left side: Door - dent(s) - Smart repair

Damage 3: Side panel - rear right side: Side panel - dent(s) - Smooth repair work

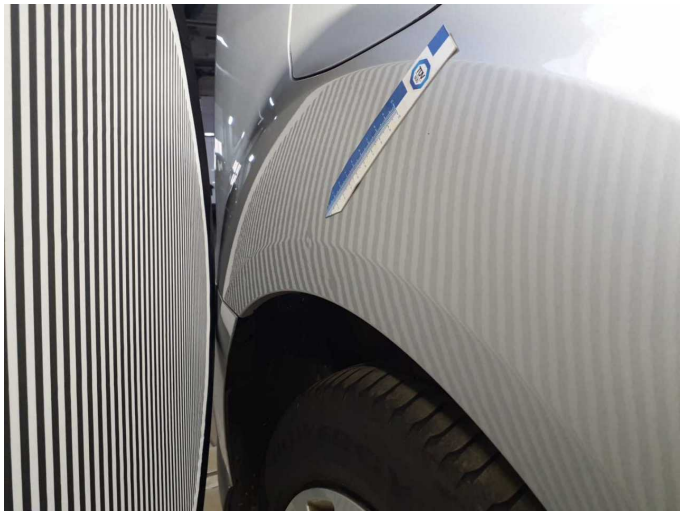
Damage 3: Side panel - rear right side: Side panel - dent(s) - Smooth repair work

Damage 4: Sliding door, right: Sliding door - dent(s) - Smart repair

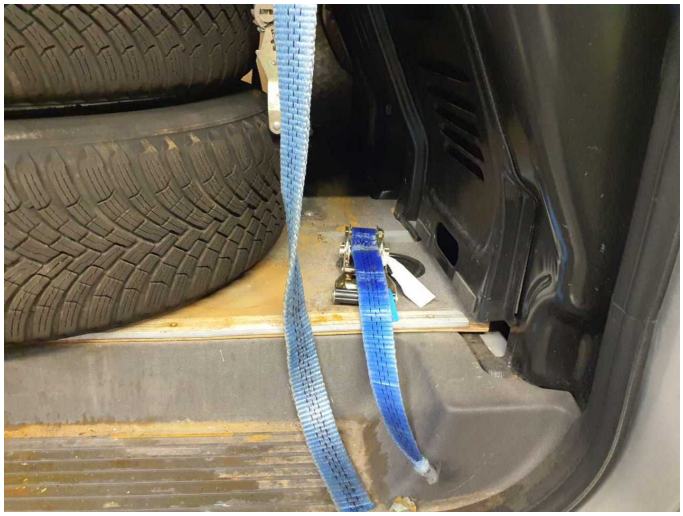
Wear and tear 2: Interior: Cargo area floor - Differs from the original configuration - No deduction

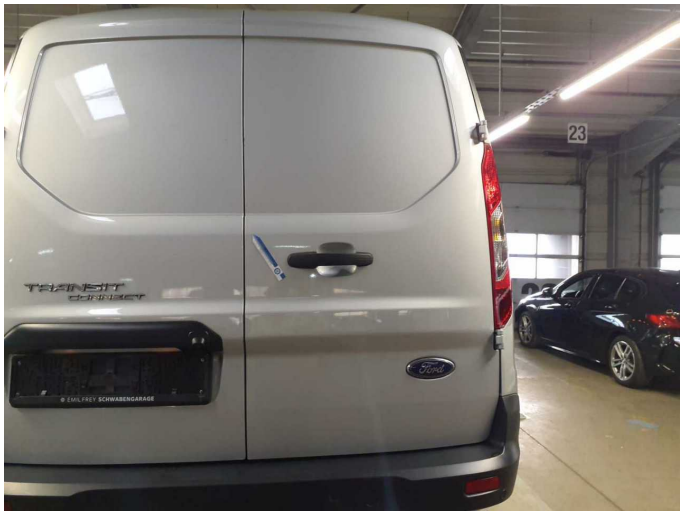
Wear and tear 2: Interior: Cargo area floor - Differs from the original configuration - No deduction

Wear and tear 3: Boot lid / rear door: Rear door - right side - Scratch(es) - No deduction
