TÜV SÜD Auto Partner GmbH
Wiesenring 2
04159 Leipzig

Expertise

Protocol number: 48241252
Order No. / Reference: 27039980
Inspection date: 21 Oct 2026

Manufacturer: Volkswagen	Model: Tiguan Allspace 2.0 TDI SCR DSG Life
VIN: WVGZZZ5NXPM020339

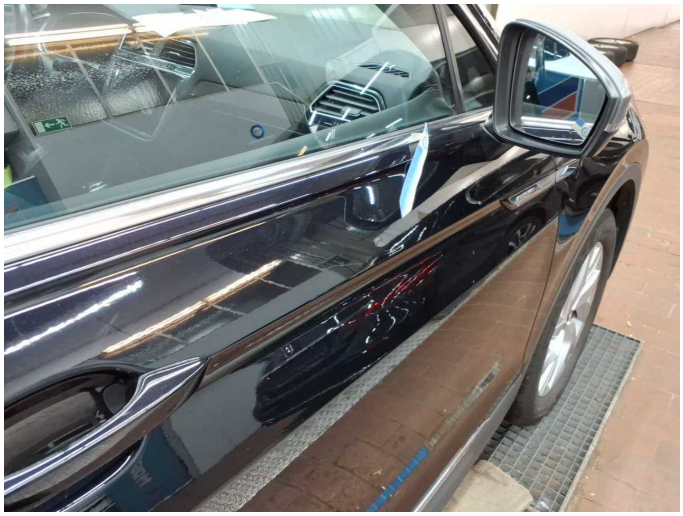
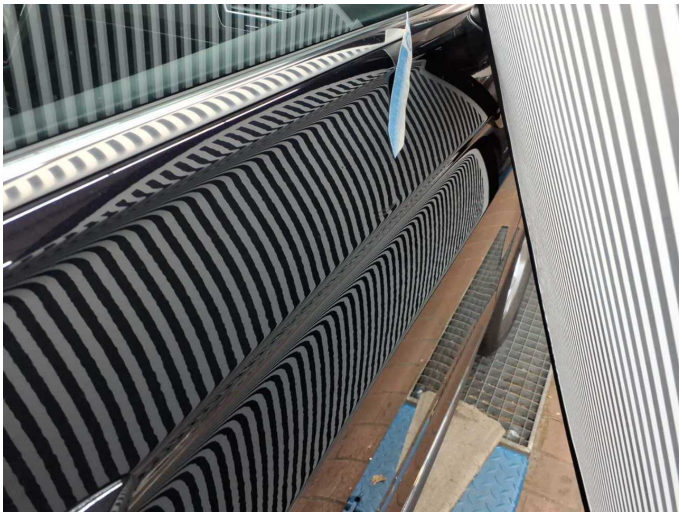
Damage 3: Door - front right side: Door - dent(s) - Paint

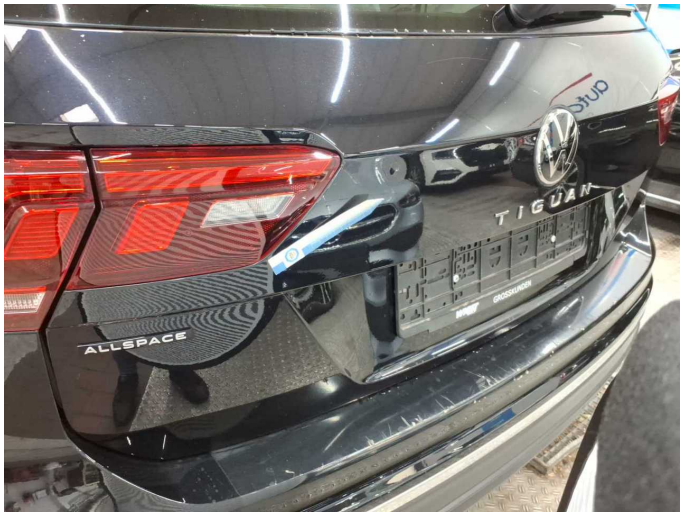
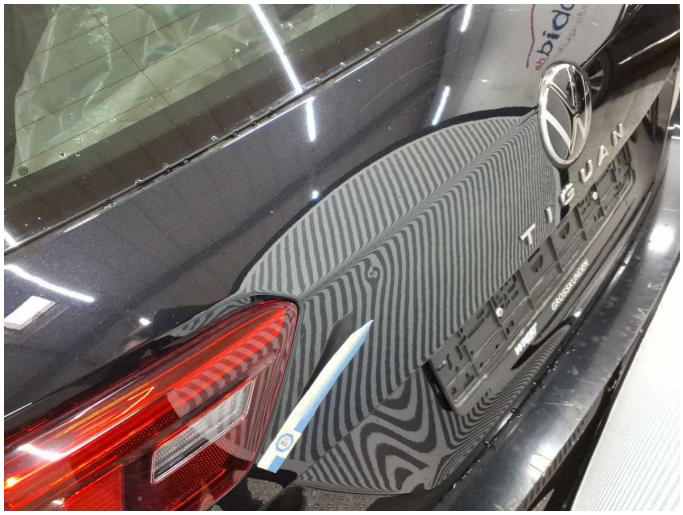
Damage 4: Boot lid / rear door: Boot lid (+ Kratzer) - dent(s) - Paint

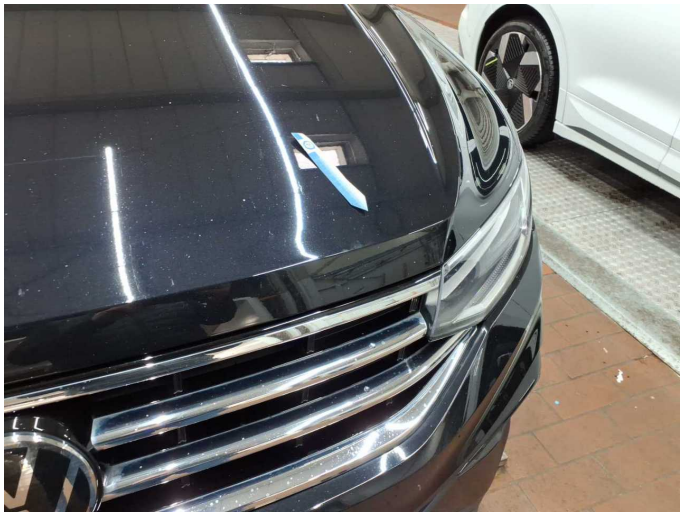
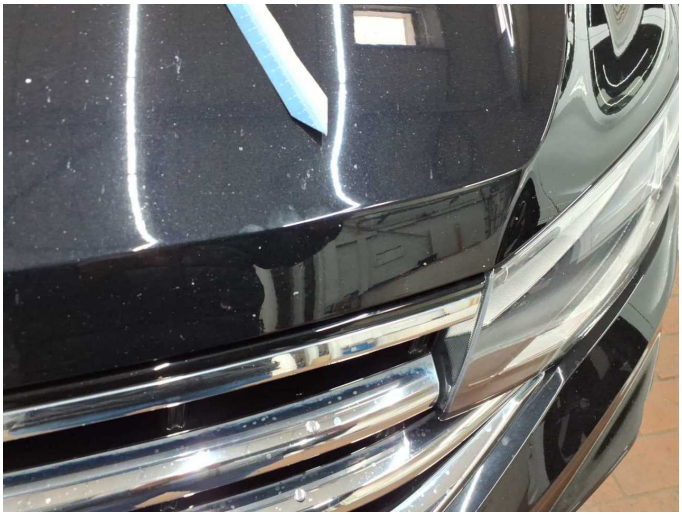
Damage 6: Bonnet: Bonnet - Stone chips - Paint

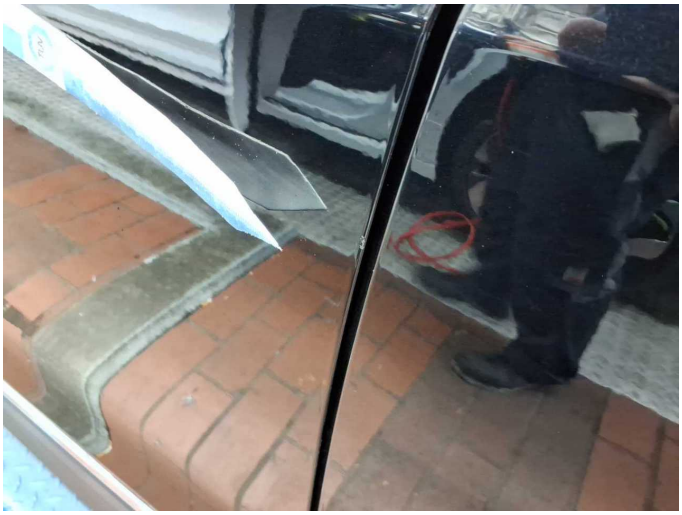
Wear and tear 4: Door - front left side: Door - Scratch(es) - No deduction
