Expertise

Protocol number: 48286192
Order No. / Reference: 27146330
Inspection date: 23 Oct 2026

Manufacturer: Ford	Model: Transit 350 L3H2 Lkw HA Trend
VIN: WF0EXXTTREPD20222

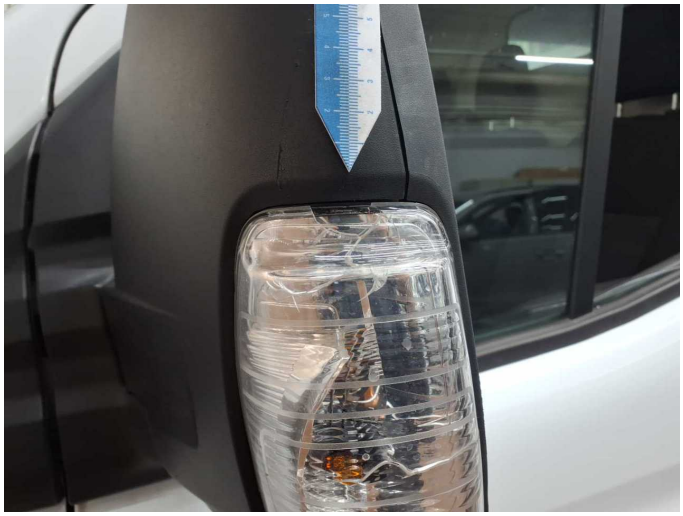
No.	Component group	Description
1	Wing mirror - right side	Mirror glass - Broken / torn - Replace
2	Indicator - front	Mirror - left side - Broken / torn - Replace
3	Indicator - front	Mirror - right side - Broken / torn - Replace
4	Side panel - rear left side	Side panel - Dent / paintcoat damage - Repair and paint

Damage 2: Indicator - front: Mirror - left side - Broken / torn - Replace
