Expertise

Protocol number: 47770329
Order No. / Reference: 27056948
Inspection date: 25 Sept 2026

Manufacturer: Audi	Model: A6 Avant 35 TDI S tronic
VIN: WAUZZZF29PN002527

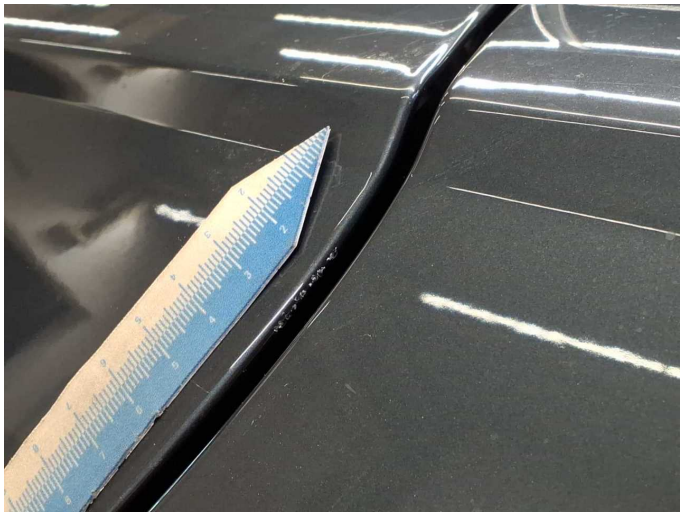
Damage 1: Door - rear left side: Door edge - Scratch(es) - Smart repair

Damage 2: Rear bumper: Rear bumper - Scratch(es) - Smart repair

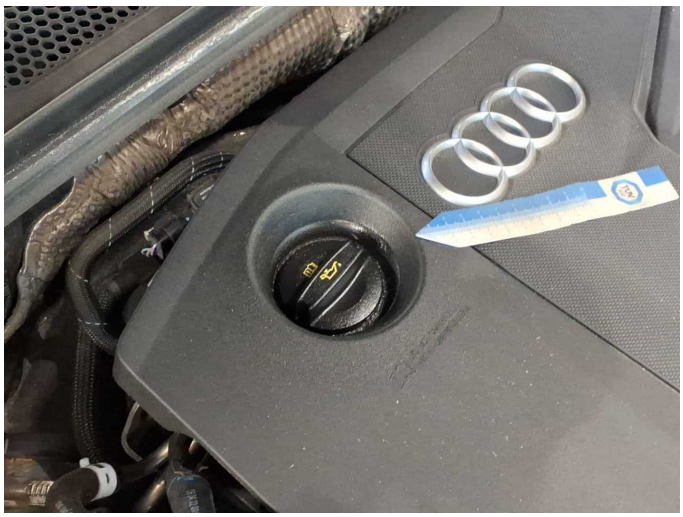
Damage 3: Engine: Engine - Leaking - Perform diagnosis

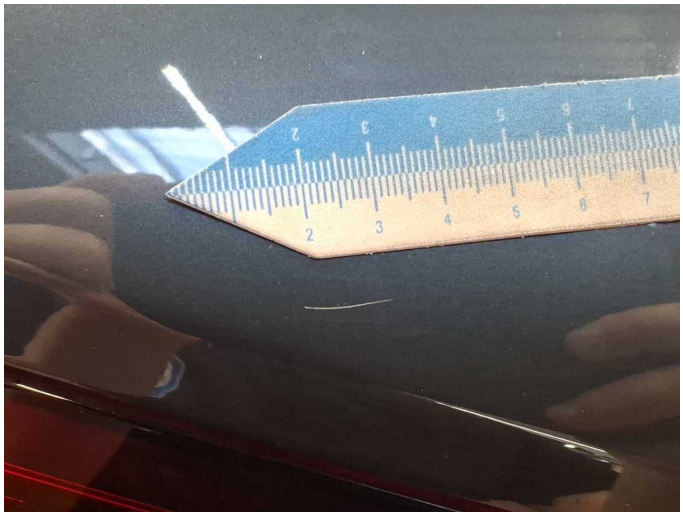
Damage 4: Boot lid / rear door: Boot lid - Scratch(es) - Smart repair
