Expertise

Protocol number: 48484360
Order No. / Reference: 27227303
Inspection date: 3 Nov 2026

Manufacturer: Ford	Model: Focus Turnier 1.5 EcoBlue Start-Stopp-System COOL&CONNECT
VIN: WF0PXXGCHPNM78636

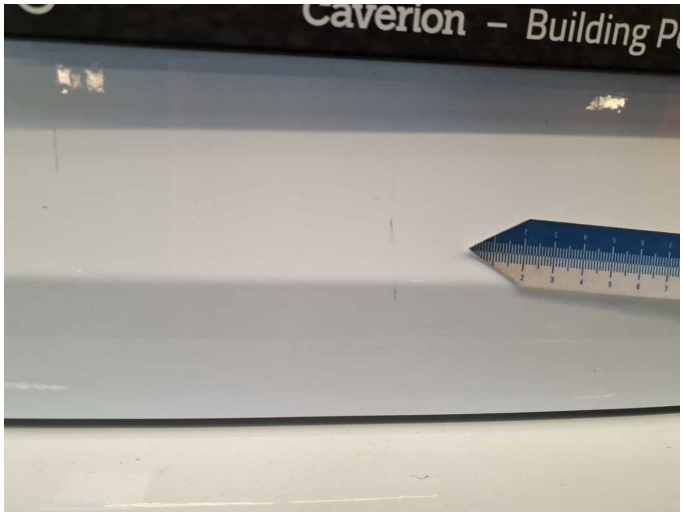
Damage 7: Boot lid / rear door: Boot lid (Teillackierung) - Scratch(es) - Paint
