Expertise

Protocol number: 48408889
Order No. / Reference: 27216444
Inspection date: 29 Oct 2026

Manufacturer: Volkswagen	Model: Caddy Cargo 2.0 TDI BMT
VIN: WV1ZZZSKZMX014811

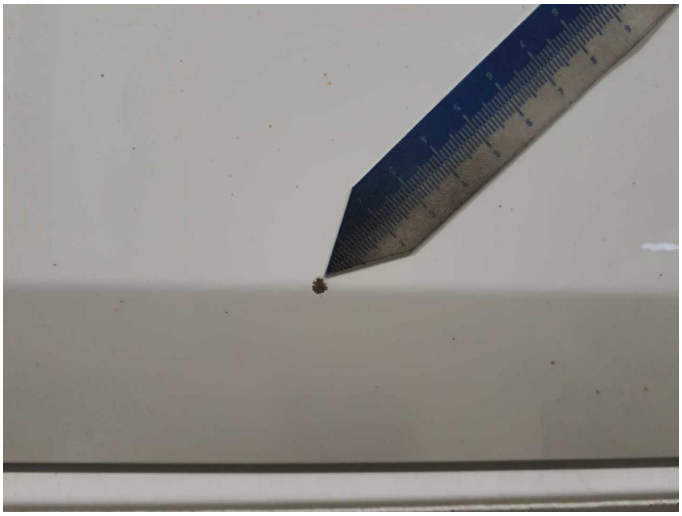
No.	Component group	Description
1	Sliding door, right	Sliding door - dent(s) - Smart repair
2	Door - front left side	Door - Scratch(es) - Smart repair
3	Door - front right side	Door - dent(s) - Smart repair
4	Body	Body - Glued / labelled - De-glue / neutralise
5	Vehicle glazing	Windscreen - Stone chips - Replace

Damage 1: Sliding door, right: Sliding door - dent(s) - Smart repair

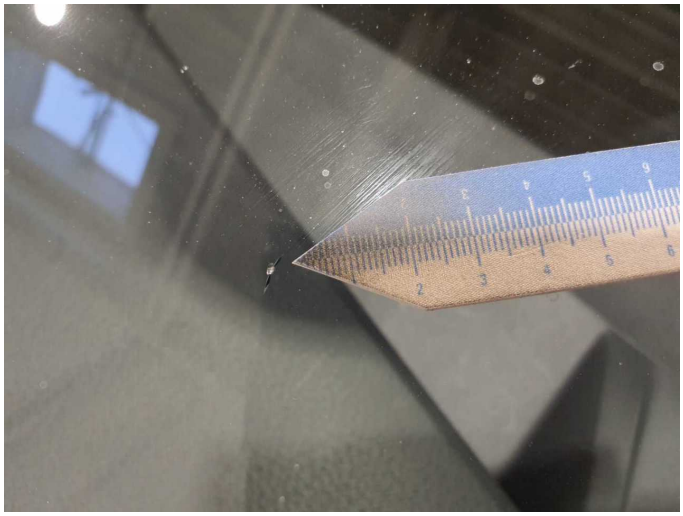
Damage 5: Vehicle glazing: Windscreen - Stone chips - Replace
